Conservation Management Plan

P11375 MANJIMUP INFANT HEALTH CENTRE (FMR)

# BUILDING CONDITION ASSESSMENT

## Manjimup Infant Health Centre (fmr)

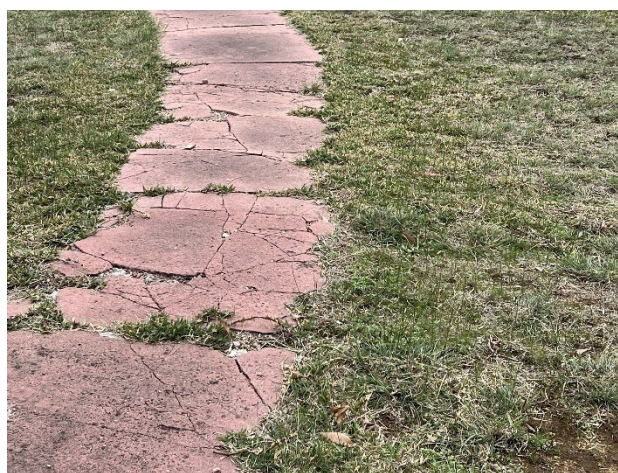
Figure 19 View showing poor condition of the concrete footpaths.

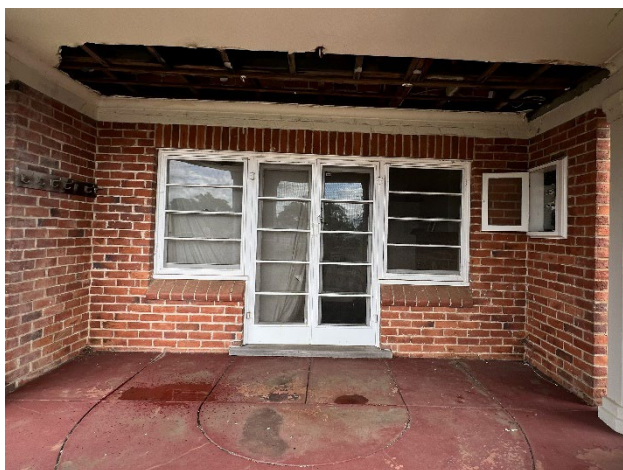
Figure 23 View of glazed door and windows on the eastern façade, and damage to the portico ceiling.

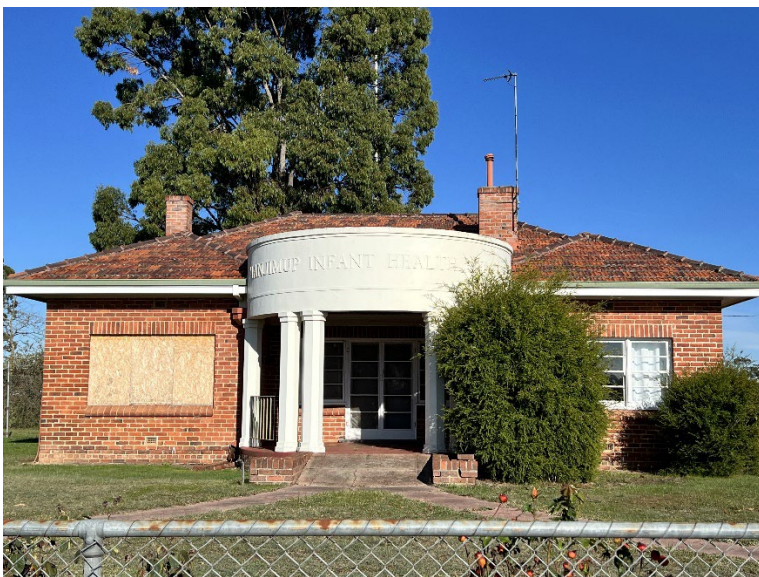
Figure 5 View of northeast elevation. Glazing is missing on the west side window which has then been boarded up.

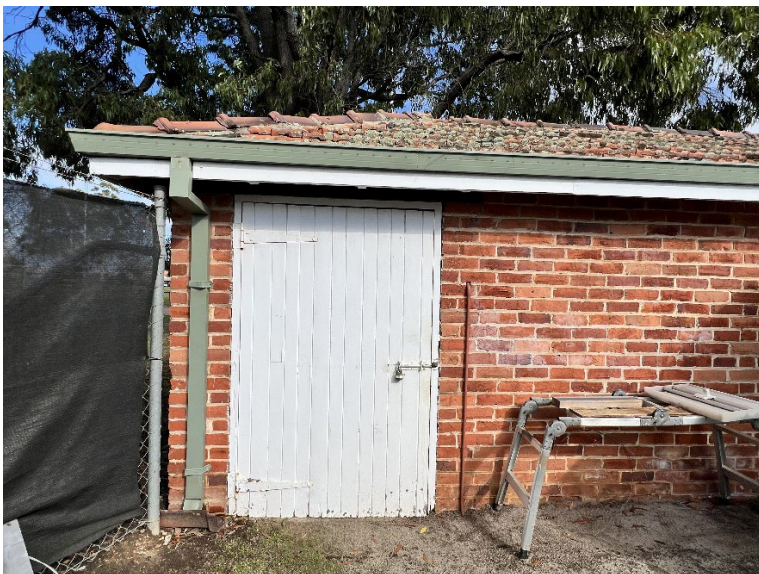
Figure 6 Partial view of north elevation of garage. Lichen growth can be seen on roof tiles.

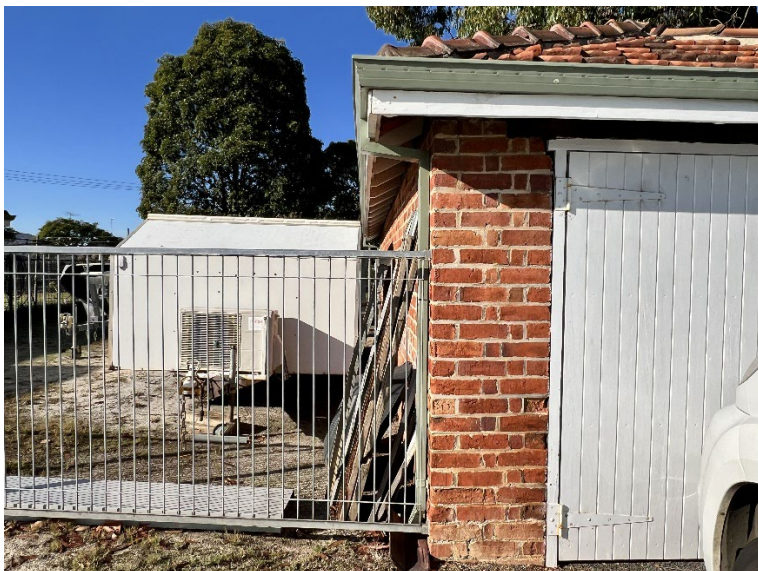
Figure 7 Partial view of the west elevation of garage showing fretting of bricks.

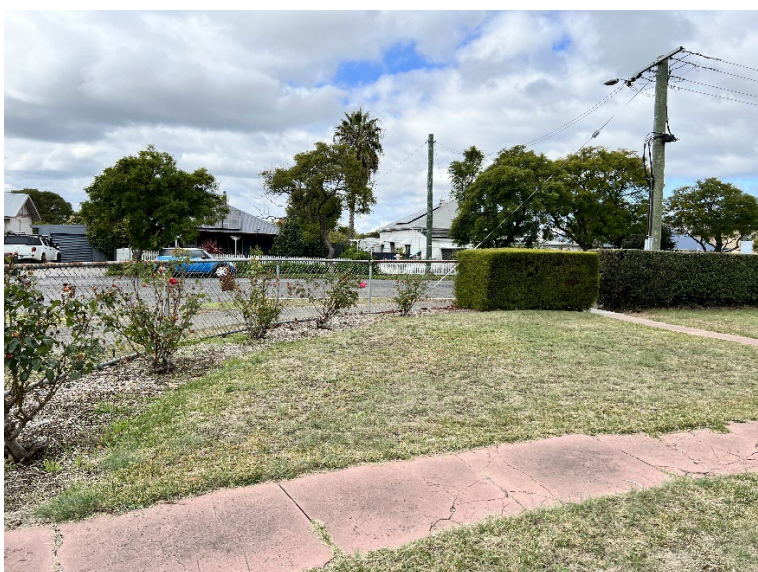
Figure 8 View of the front yard showing the original hedge and rose garden. Cracks on concrete path evident.

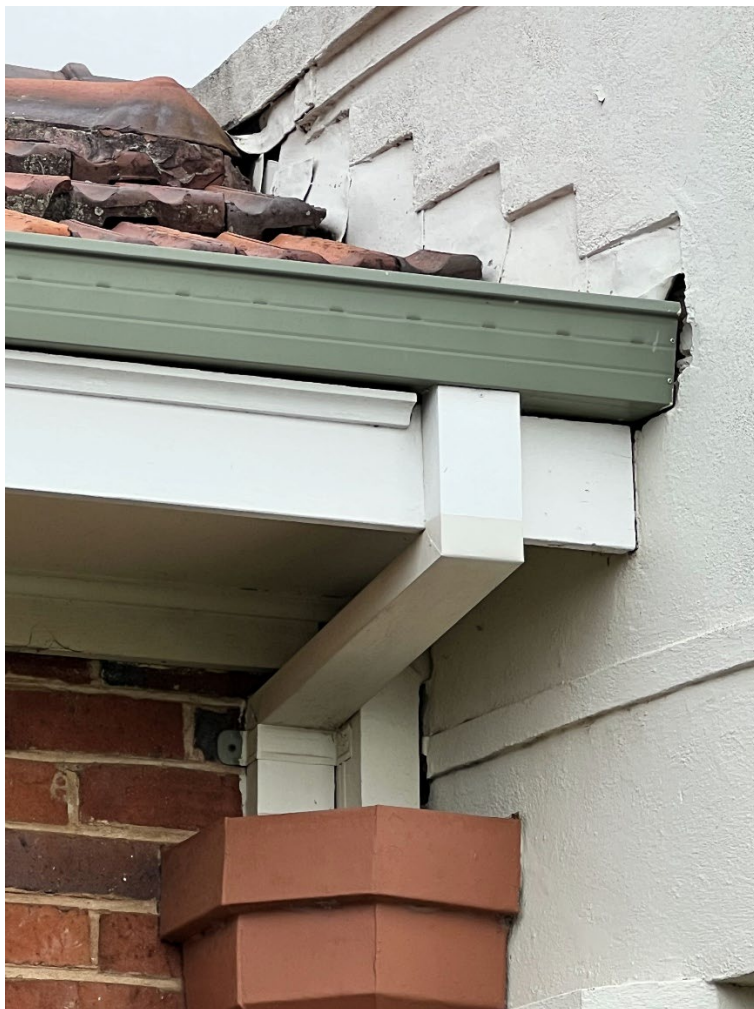
Figure 9 Holes on render and step flashings. Missing timber scotia.

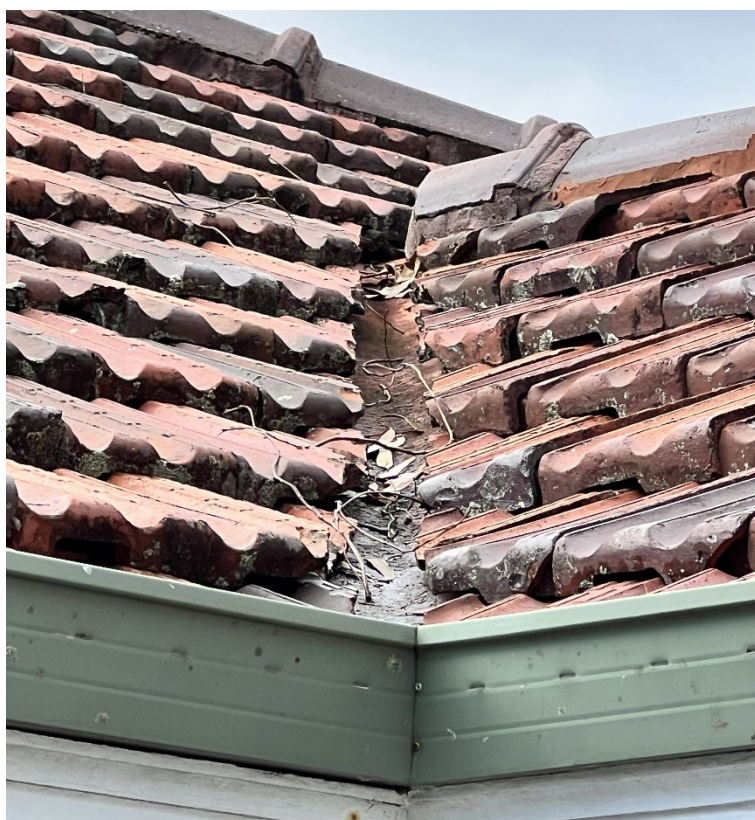
Figure 10 Valley gutter is severely deteriorated. Roof tiles have lichen growth. An accumulation of dried leaves and branches from nearby tree.

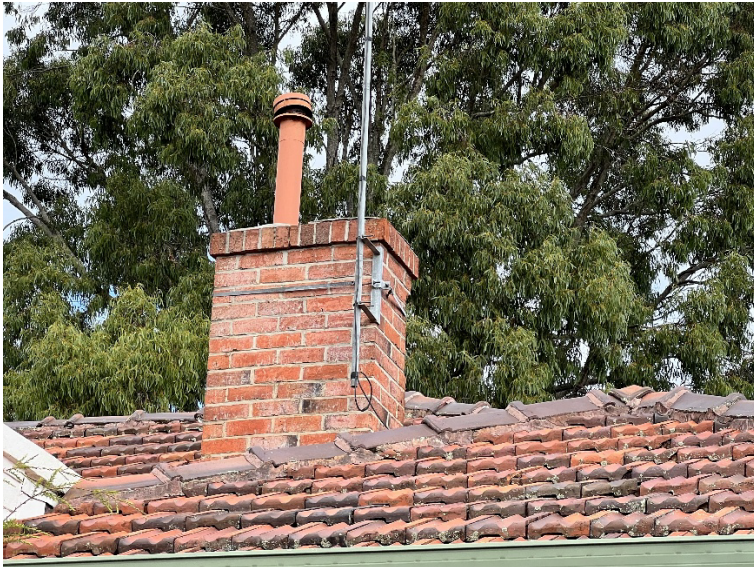
Figure 11 Antenna mast fixed to chimney stack.

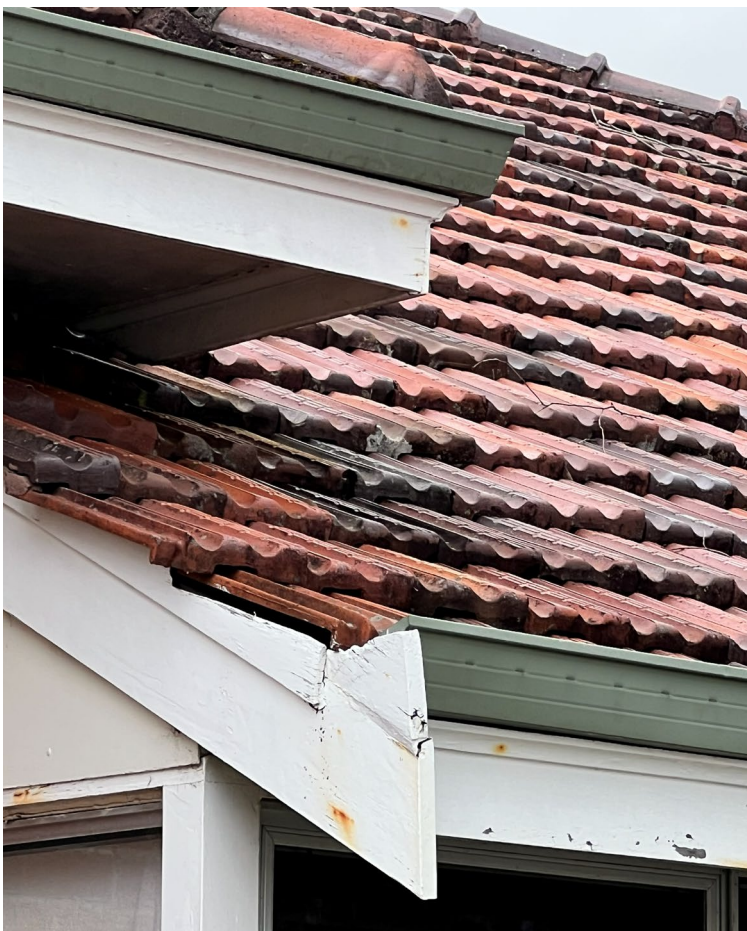
Figure 12 The end roof tile is broken causing water ingress. Timber rot is present at the ends of timber bargeboard. Timber fixings are corroded.

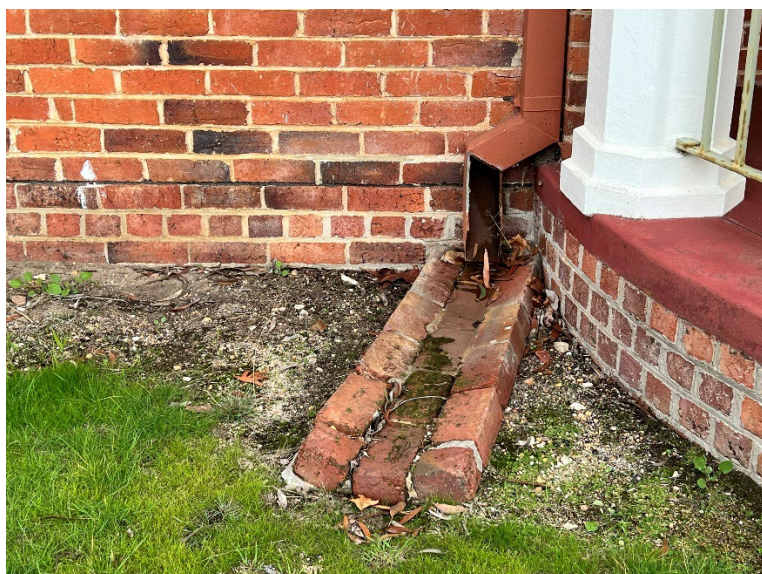
Figure 13 Damaged gutter discharging onto brick scupper drain.

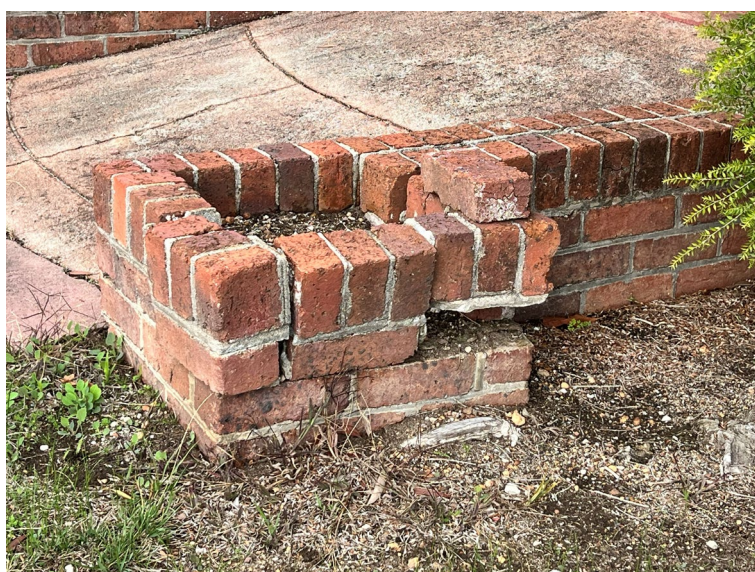
Figure 14 Damaged brick planter box.

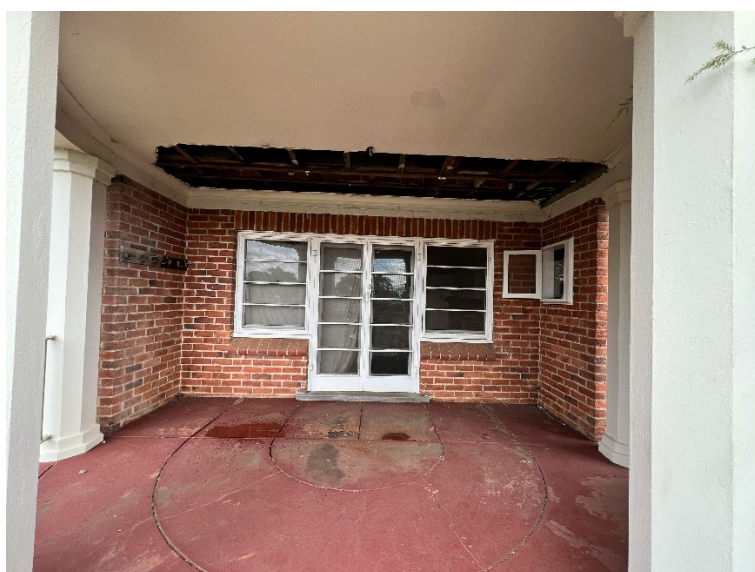
Figure 15 Collapsed ceiling to portico due to water ingress.

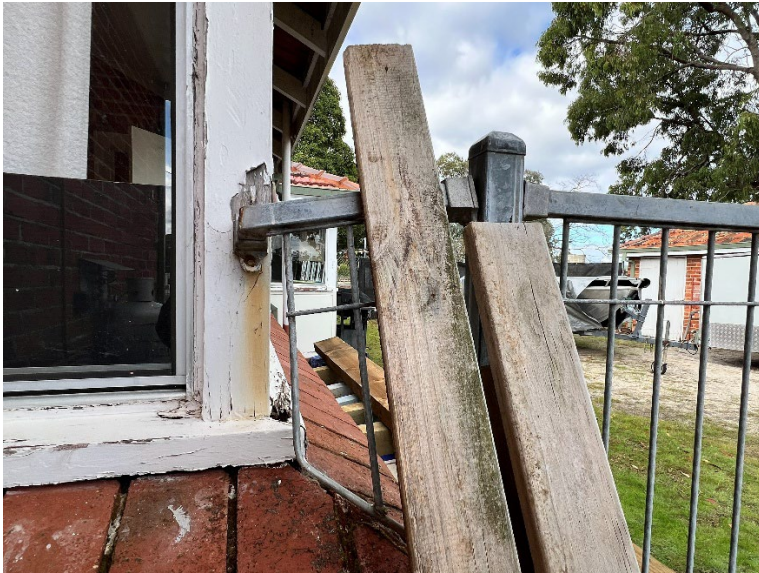
Figure 16 Badly deteriorated timber post attributed to weathering and corroded fence fixing. Mortar missing on brick sill.

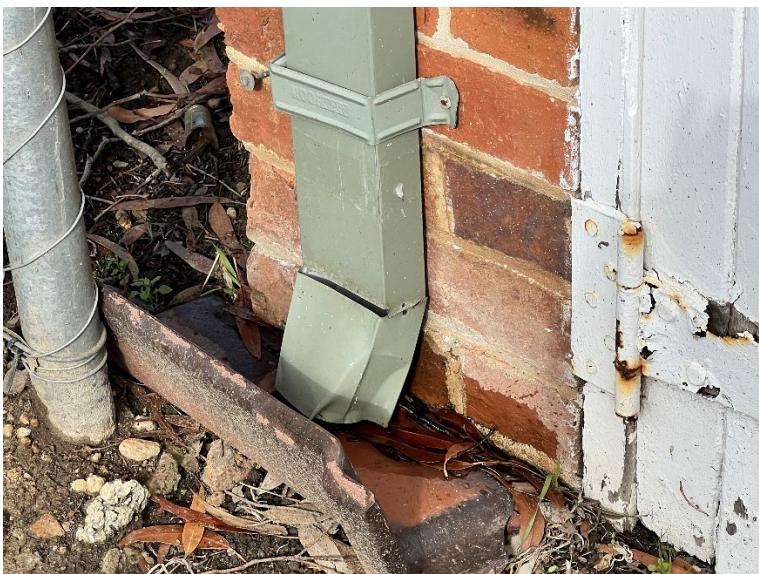
Figure 17 Damaged downpipe discharging onto roof tile. Hinge to garage door is heavily corroded.

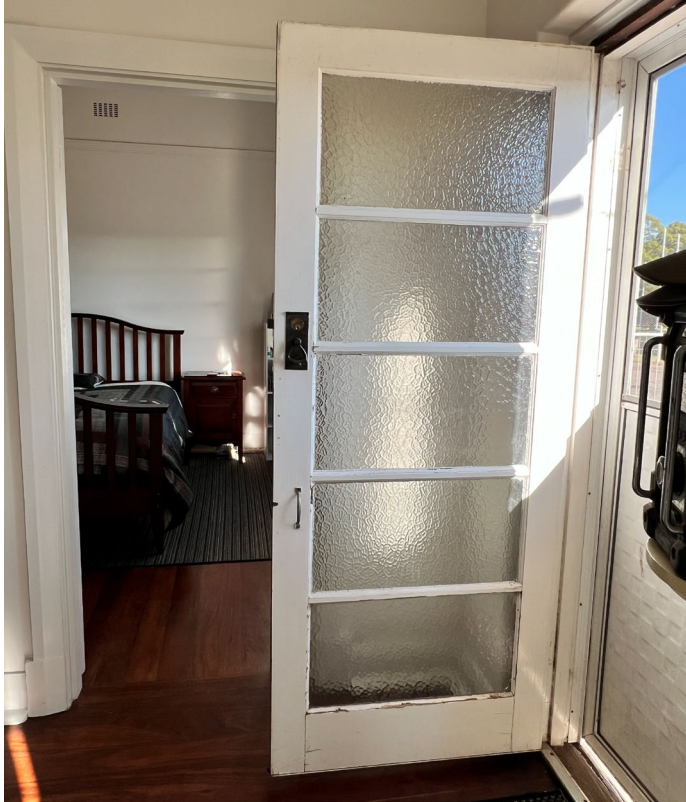
Figure 18 Side entry door. Minor timber repairs required to the bottom of timber door.

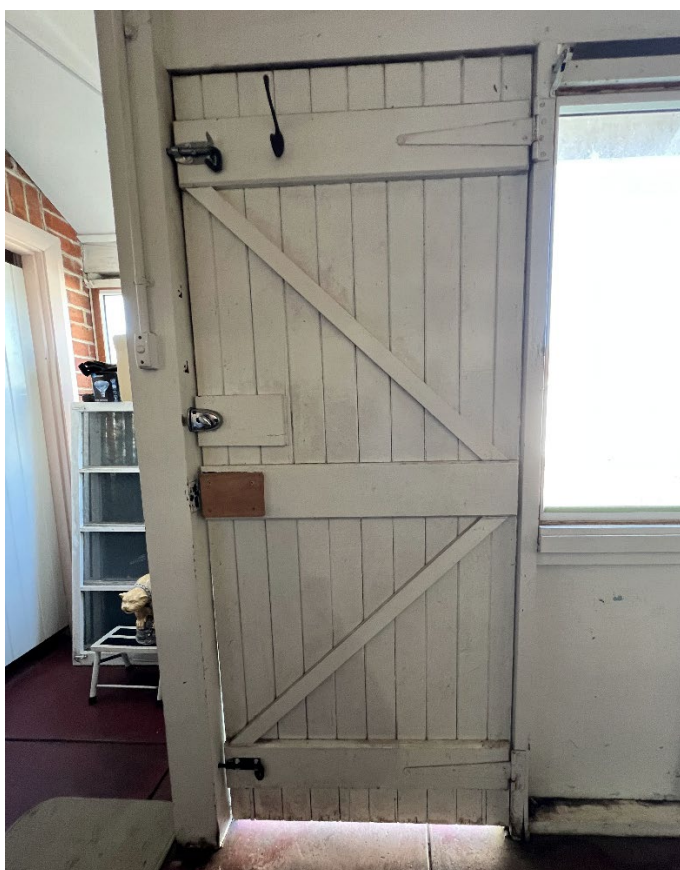
Figure 21 Ledge and brace batten door to the rear. Minor timber repairs to the bottom of door.

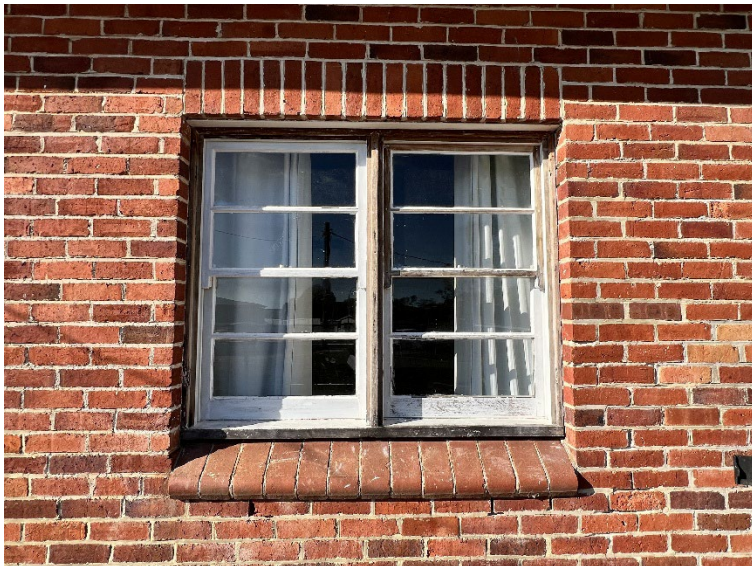
Figure 22 Two combined double hung sash windows. Timber frame and sill are showing signs of wear. Casement flyscreen missing.

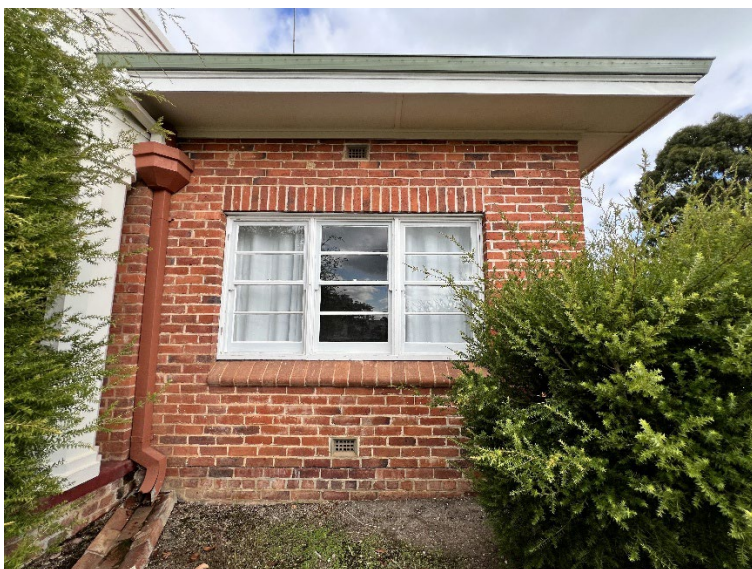
Figure 23 3 combined double hung sash windows. Casement flyscreen missing.

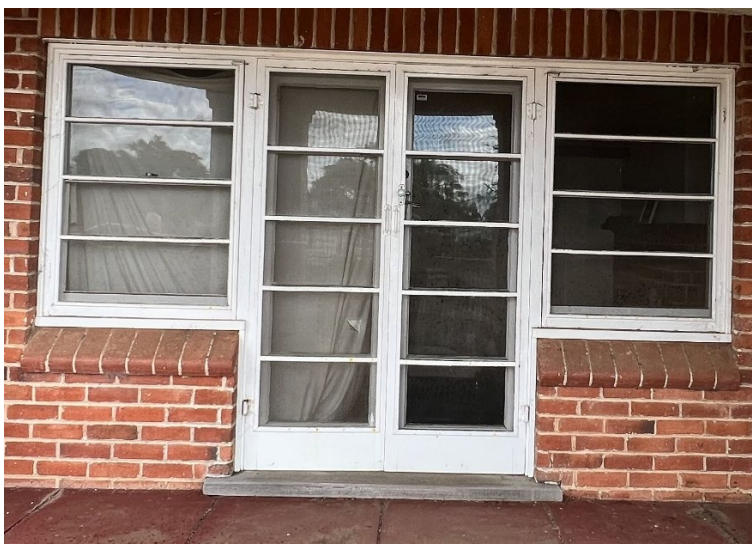
Figure 24 Main entry double door and flyscreen. Double hung sash sidelights with casement flyscreen. Timber door threshold generally aged.

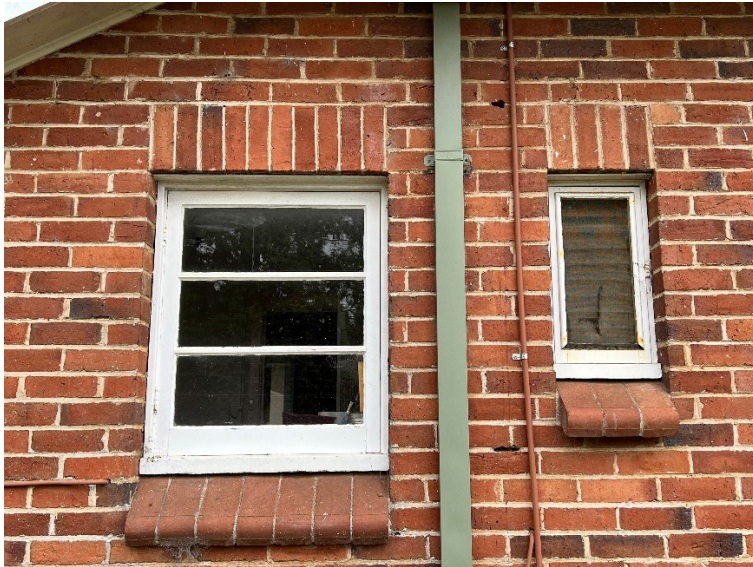
Figure 25 Multi paned timber casement window to laundry. Fixed wire mesh laminated glass louvres to WC. Mesh to flyscreen is torn.

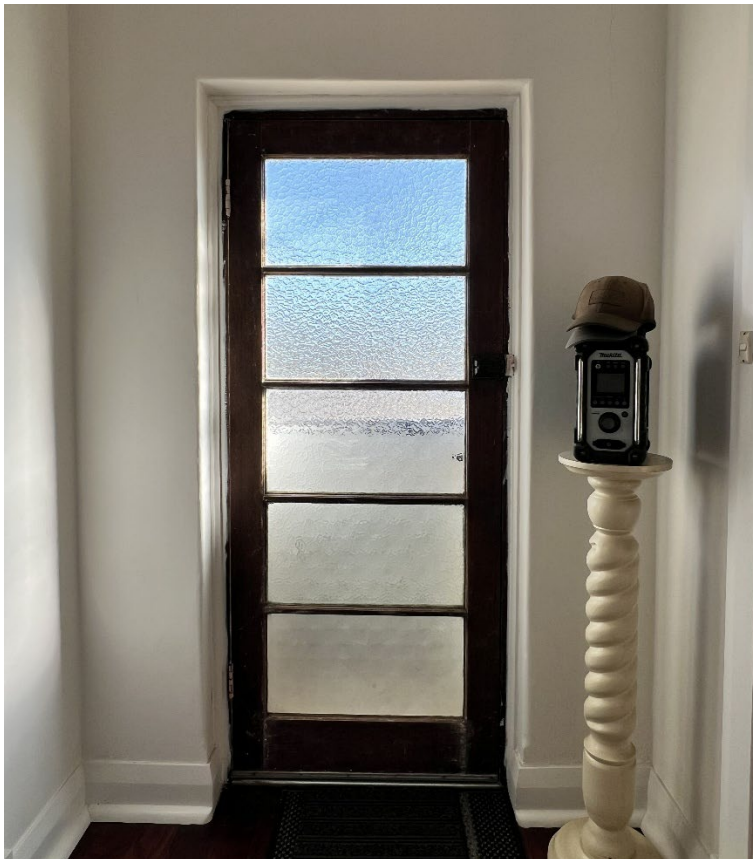
Figure 26 View of side entry door from foyer. There is a vertical crack at the top right-hand side of the wall.

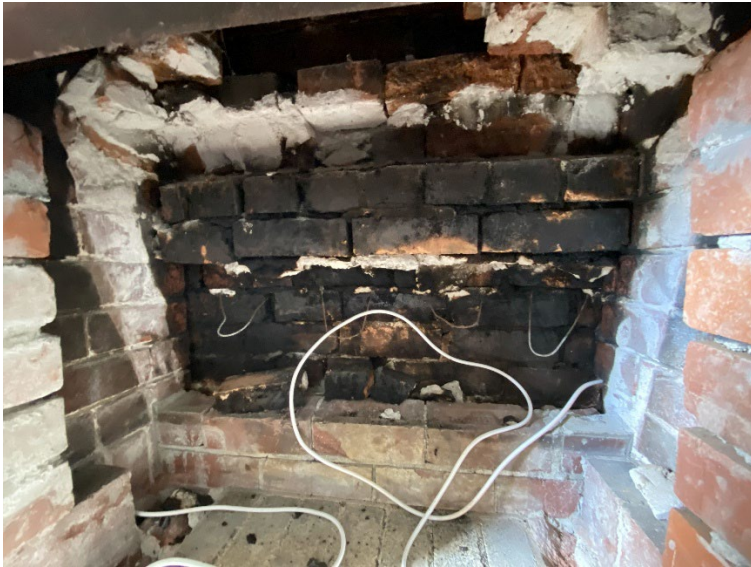
Figure 29 Internal view of firebox in living room. The firebox is severely damaged and has partially collapsed.

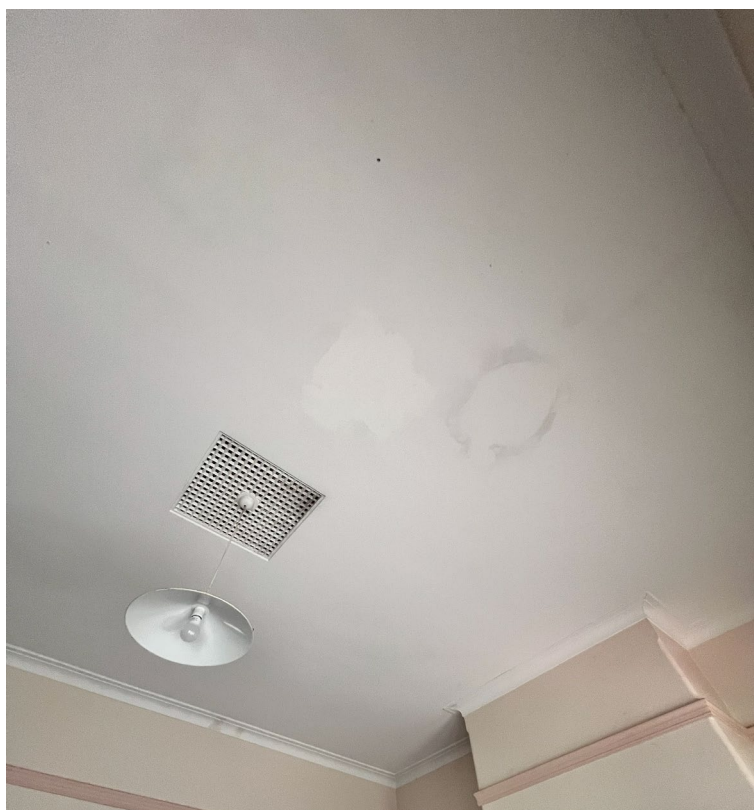
Figure 33 Small holes to ceiling. Scuff marks and stains present.

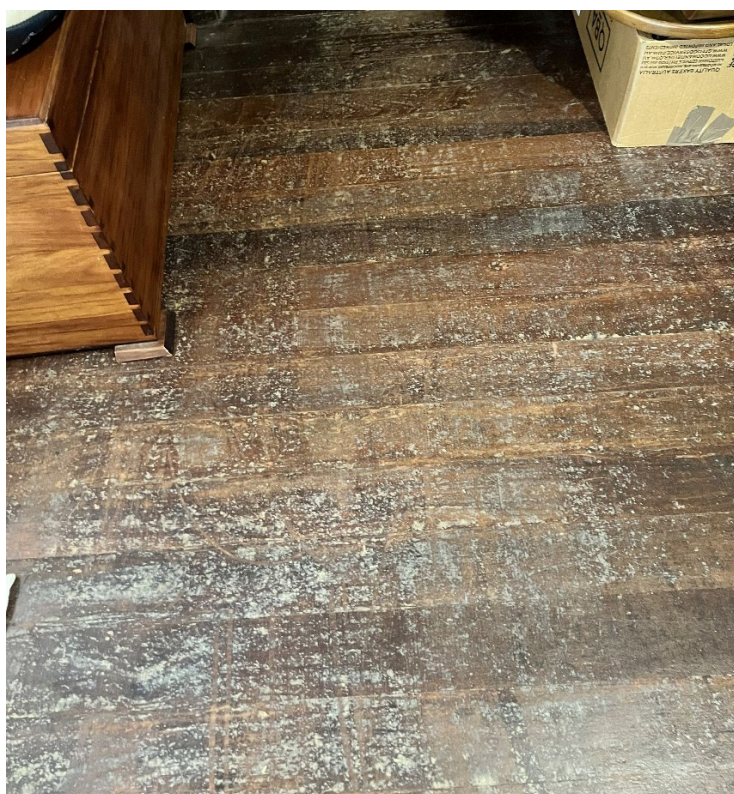
Figure 34 Carpet adhesive residue on timber floorboards.

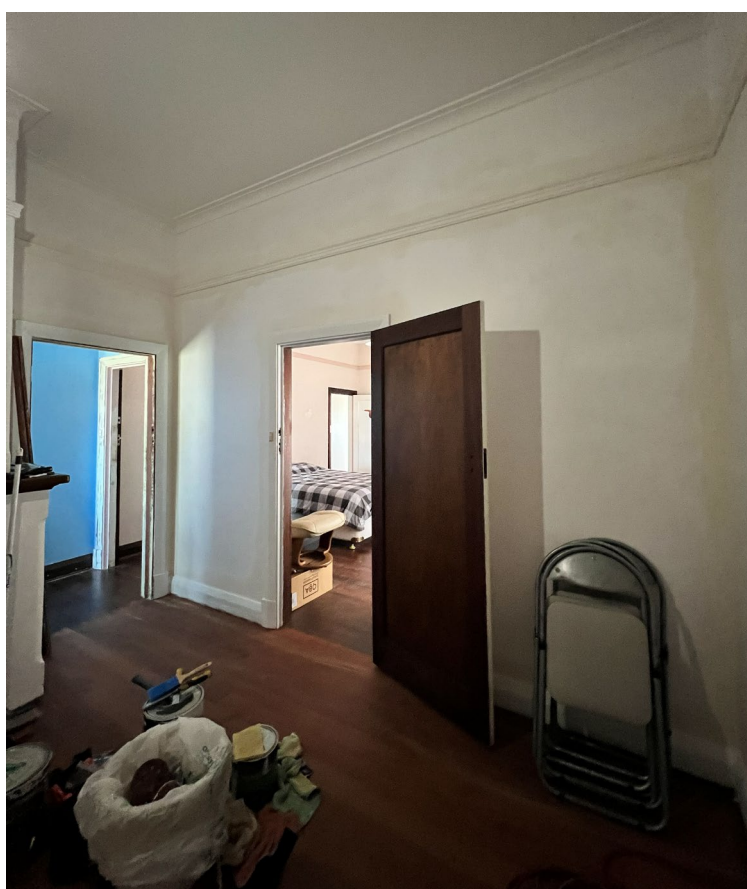
Figure 36 Timber floorboards have been lightly sanded. Scuff marks and stains on walls.

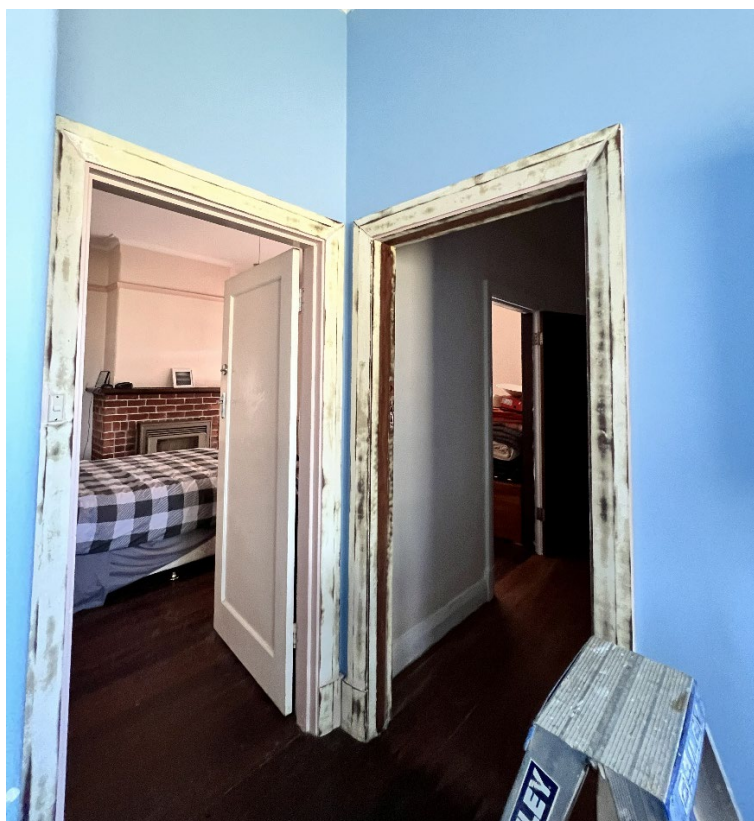
Figure 39 Door architraves to be repainted.

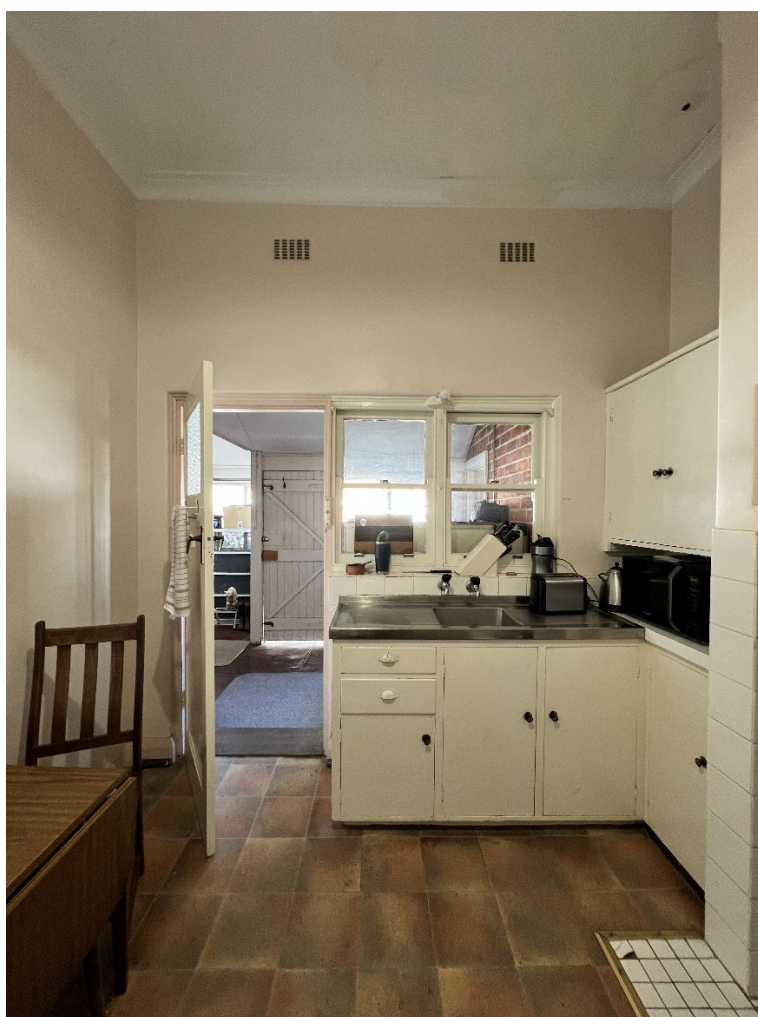
Figure 40 View of kitchen. There is significant water damage to ceiling. Kitchen cabinetry is intact.

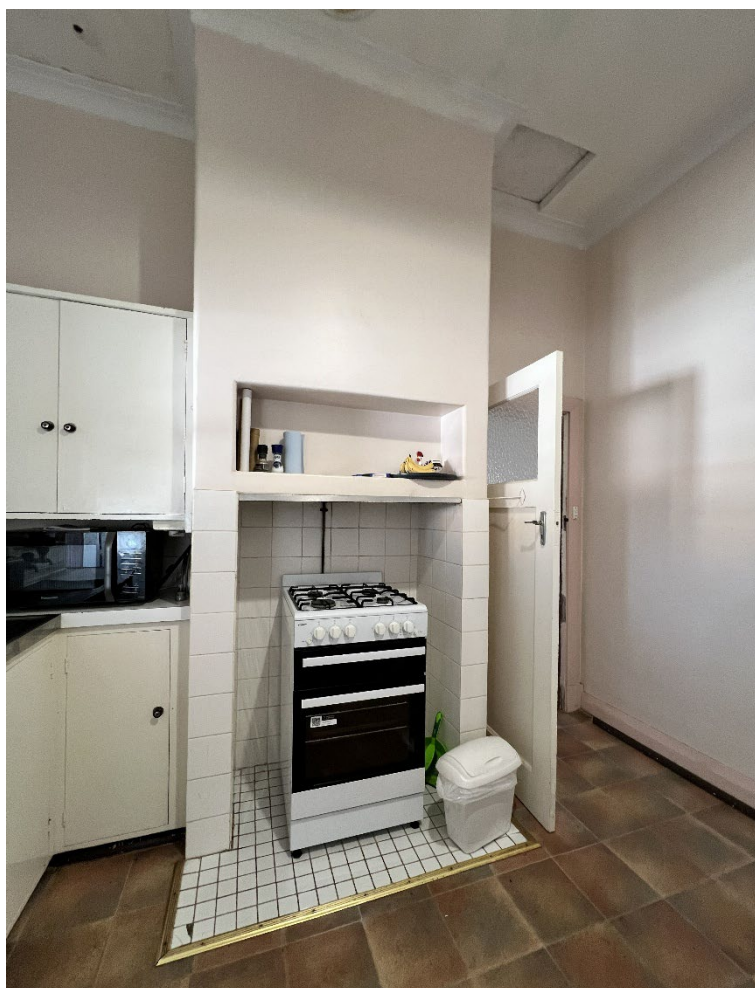
Figure 41 Tiled fireplace. There is a broken tile at the corner of hearth.

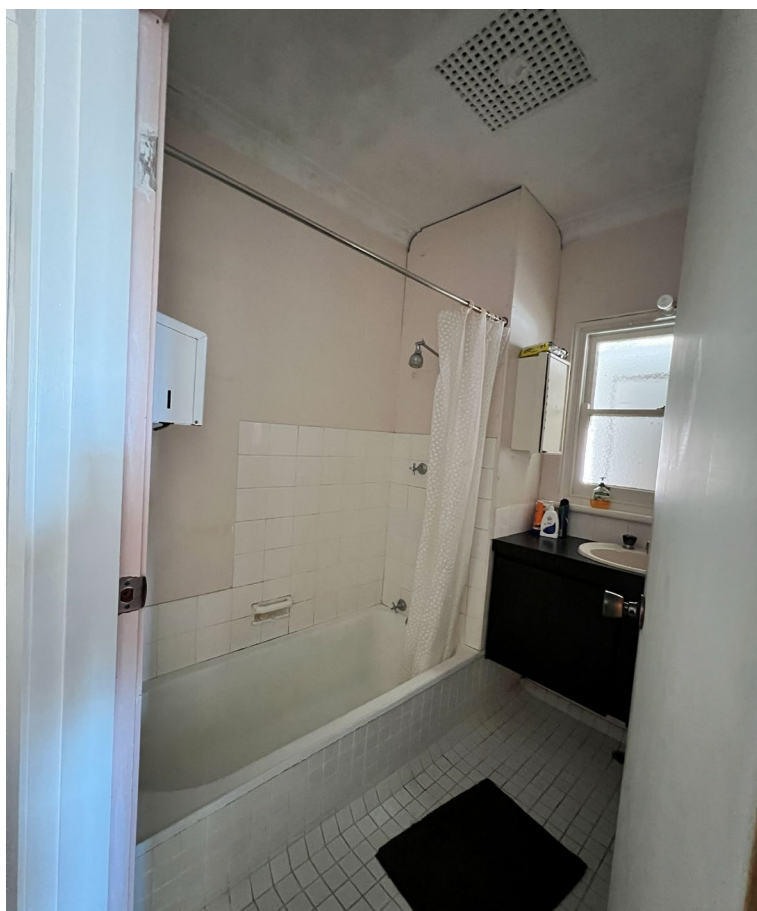
Figure 45 Plaster ceiling to bath is heavily stained. Floor and wall tiles are intact.

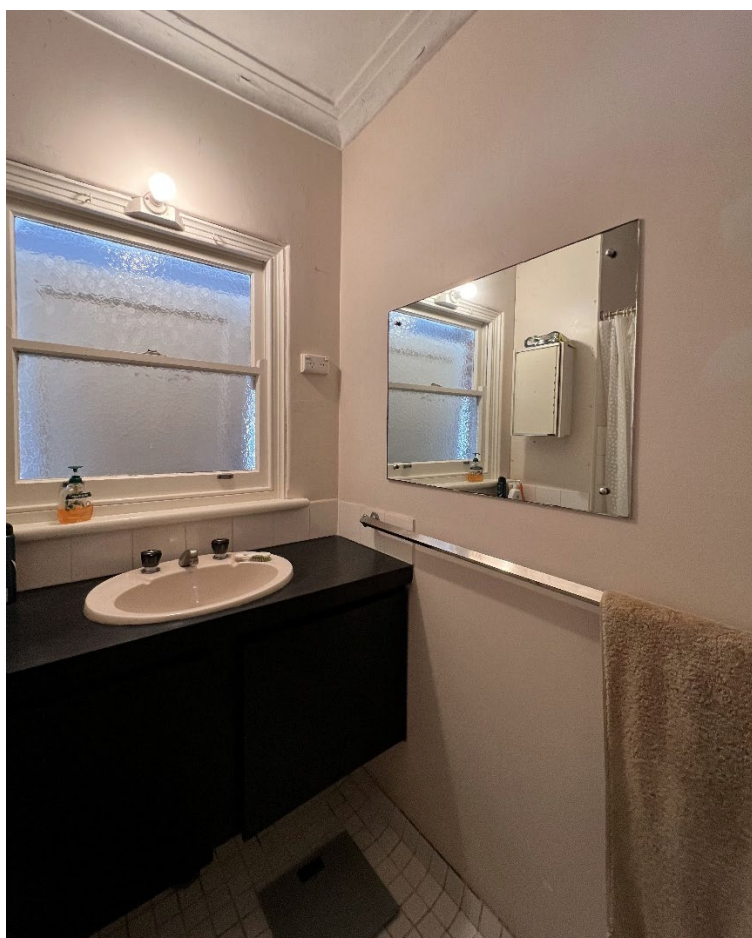
Figure 46 Paint peeling on cornices. Scuff marks on wall.

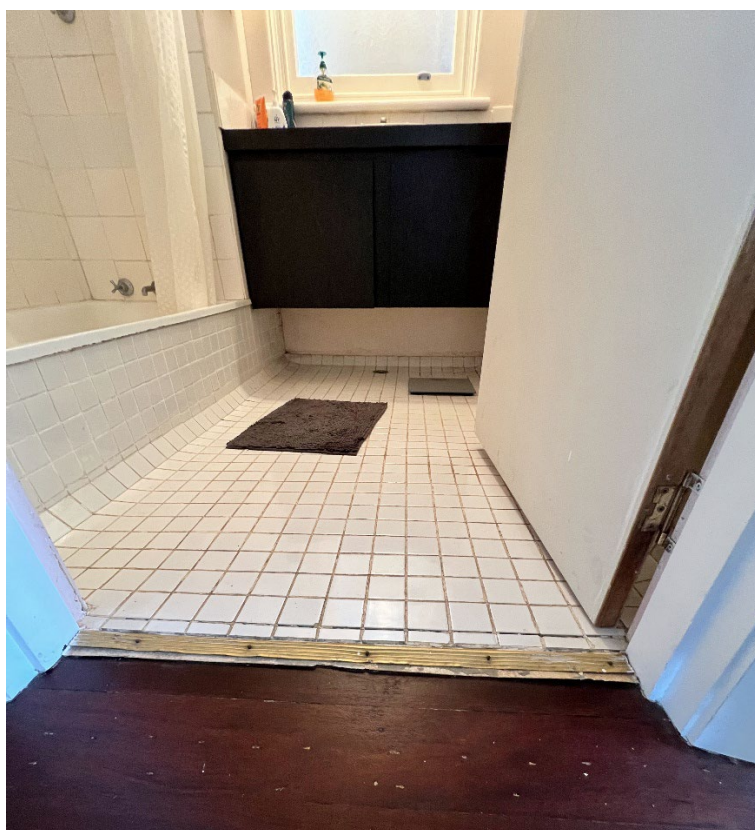
Figure 47 Transition trim is showing signs of wear. Tile grout is dirty.

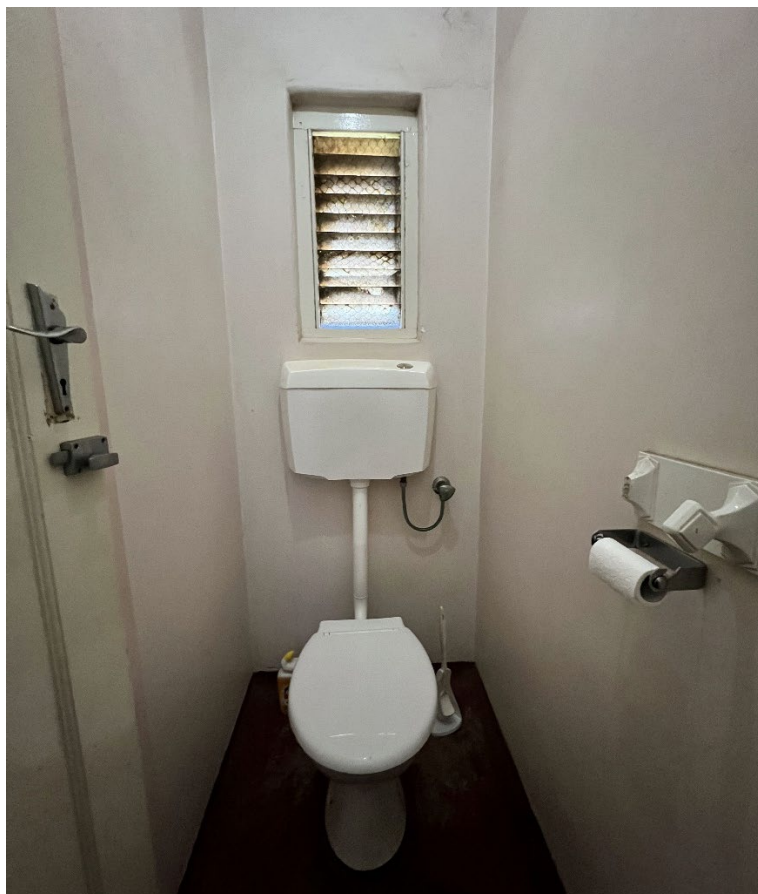
Figure 51 Accumulation of dirt and grime on glass louvres. Original toilet roll holder is broken.

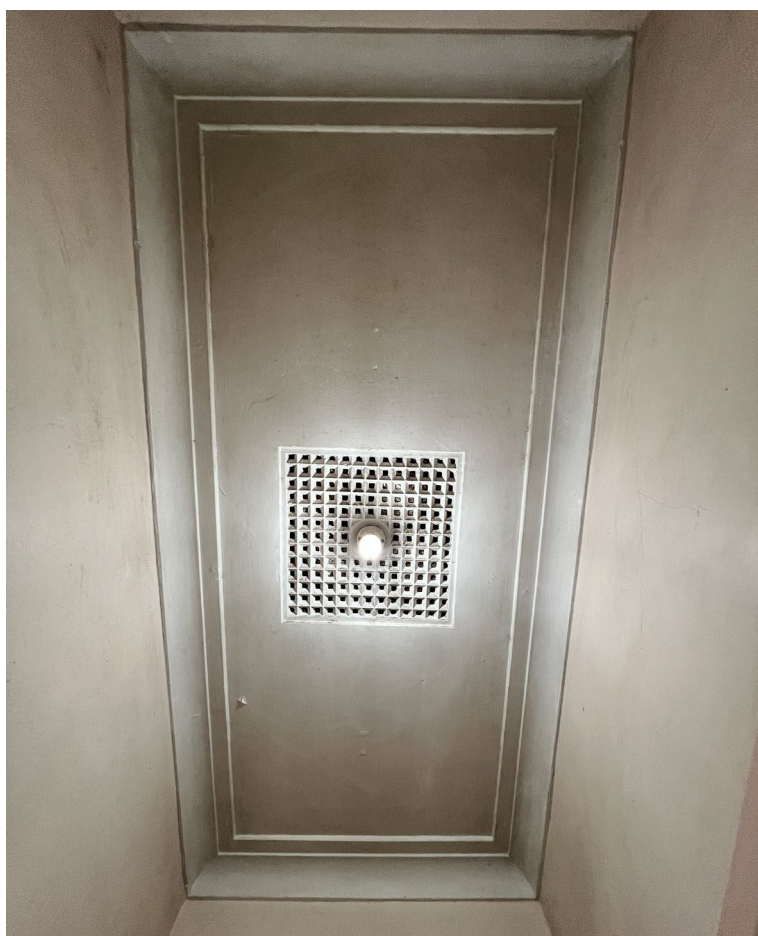
Figure 52 Plaster ceiling to WC1 is heavily soiled.

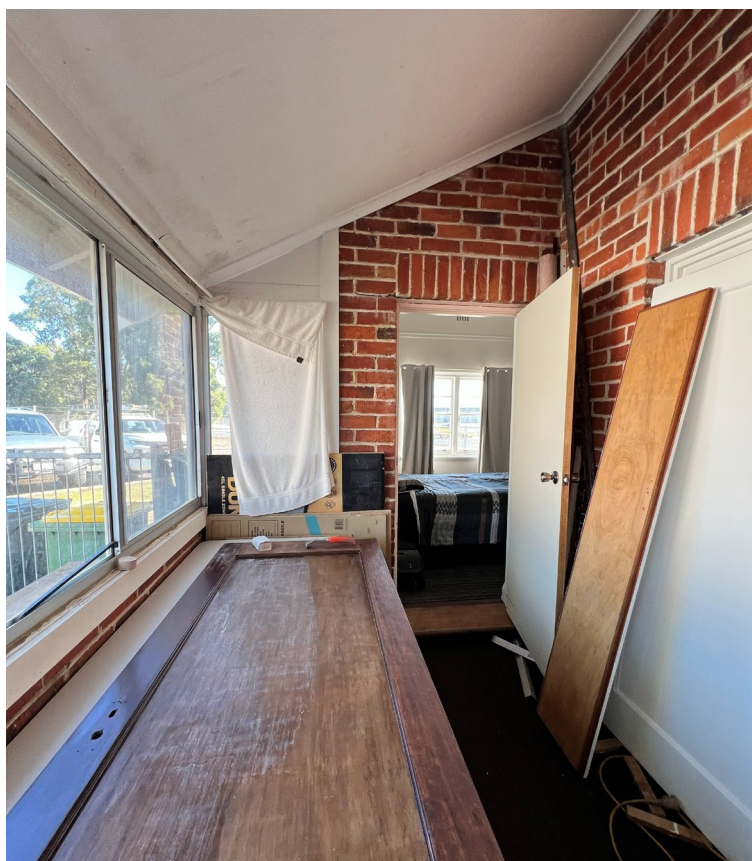
Figure 53 View of sleepout with the bedroom on the background. Small section of asbestos cement sheeting above window.

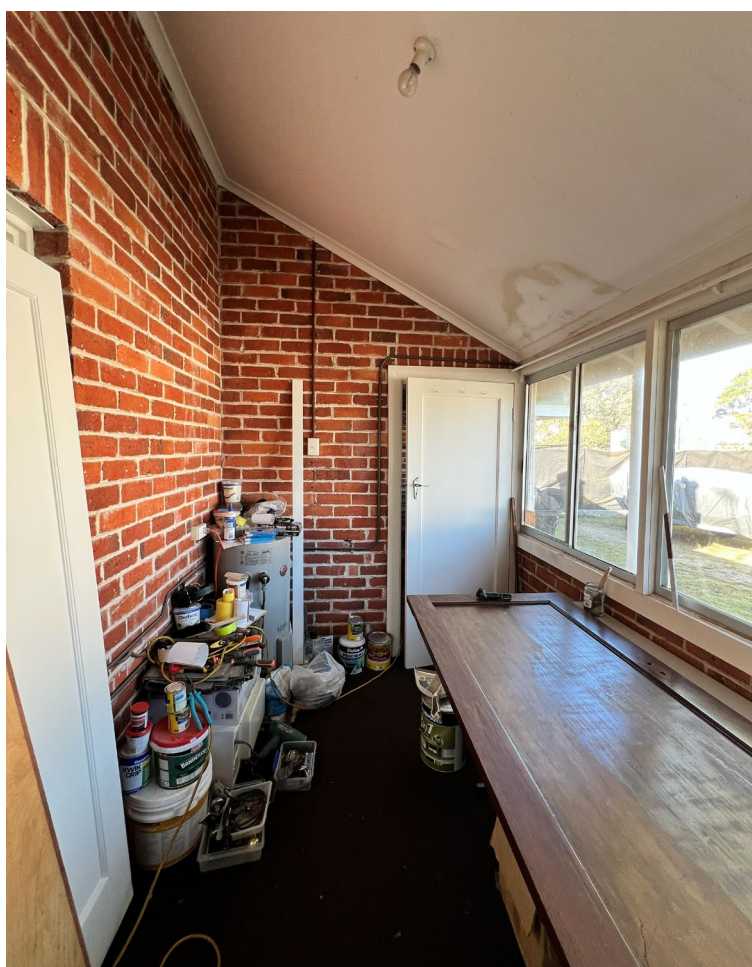
Figure 54 Water damage to ceiling.

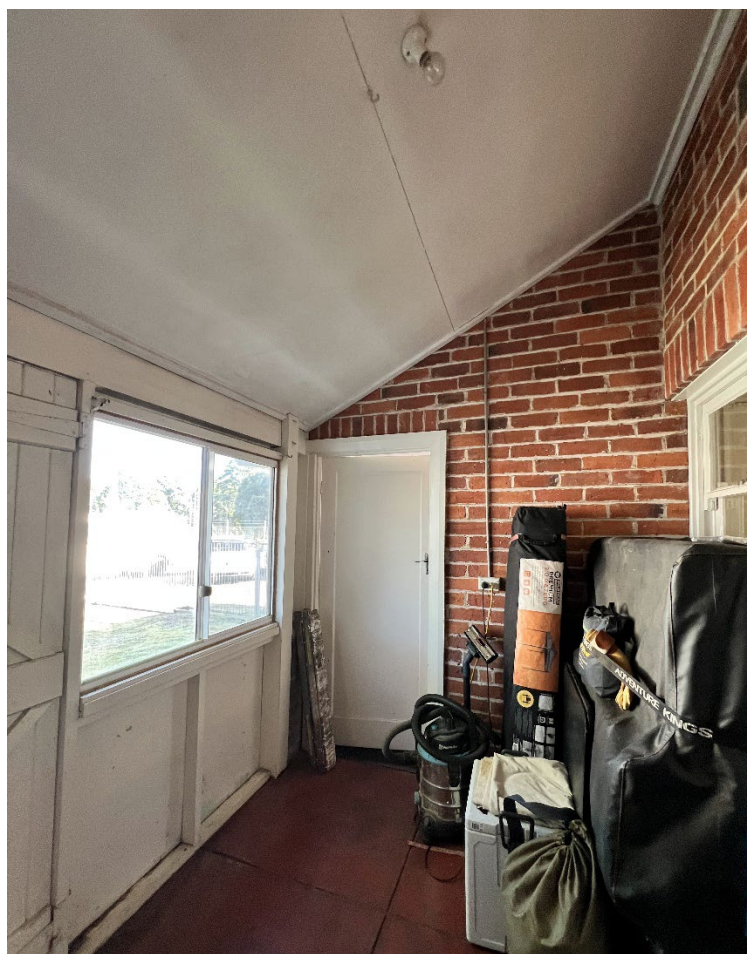
Figure 56 Asbestos sheet lining to bottom of windows. Ceiling frame visible due to accumulation of dust and grime on ceiling.

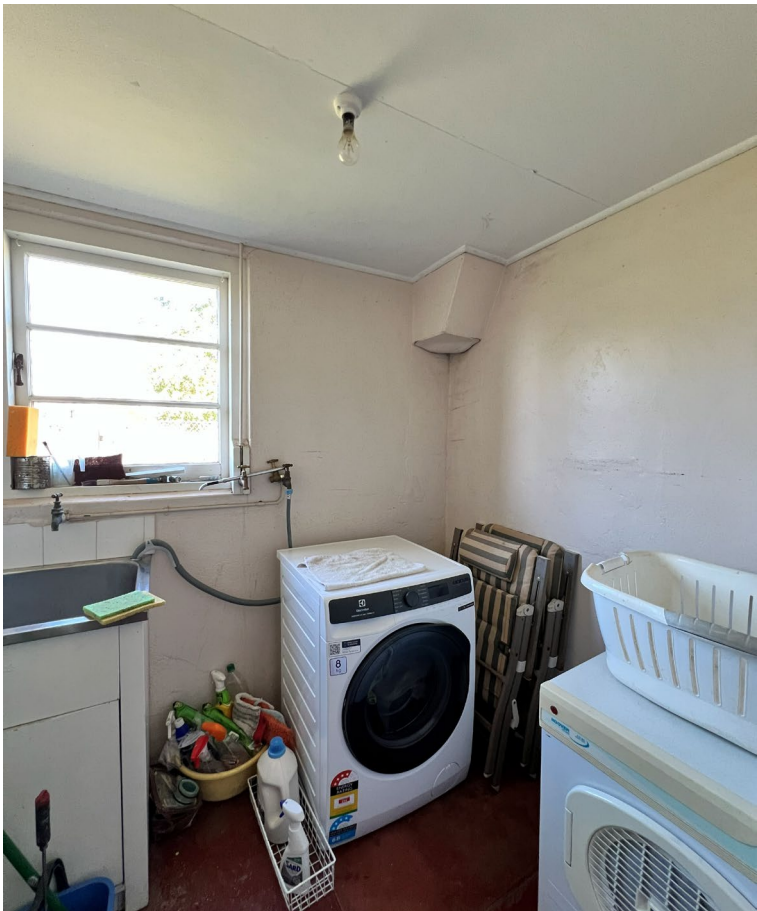
Figure 58    There is a joint separation between plasterboard.

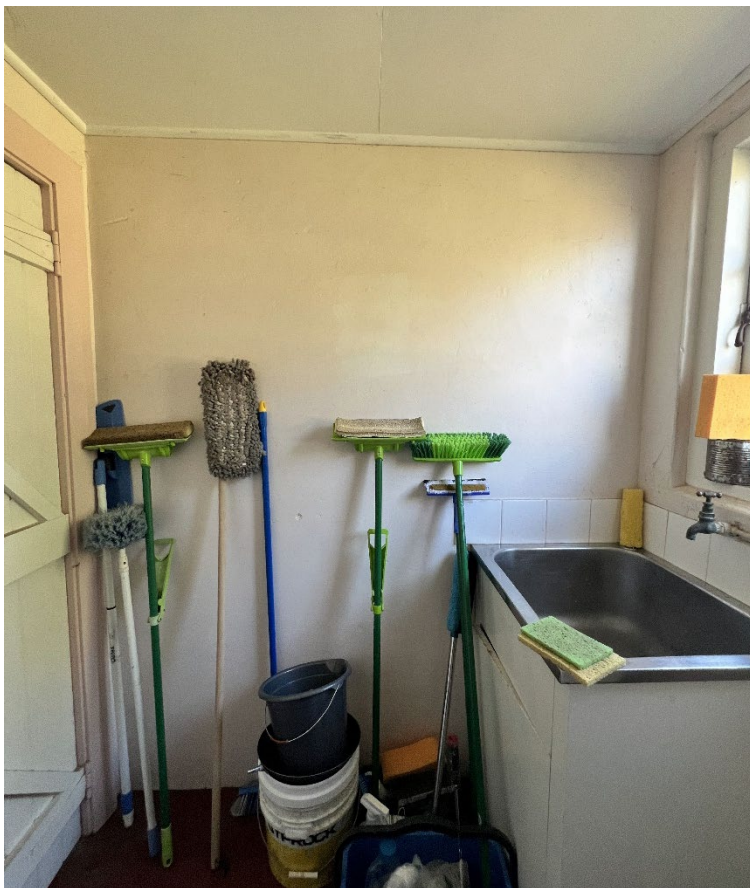
Figure 59 Laundry trough with tiled splashback is intact. Scuff marks and stains to walls, ceiling and trims.
