Conservation Management Plan

P11375 MANJIMUP INFANT HEALTH CENTRE (FMR)

# BUILDING CONDITION ASSESSMENT

## Manjimup Infant Health Centre (fmr)

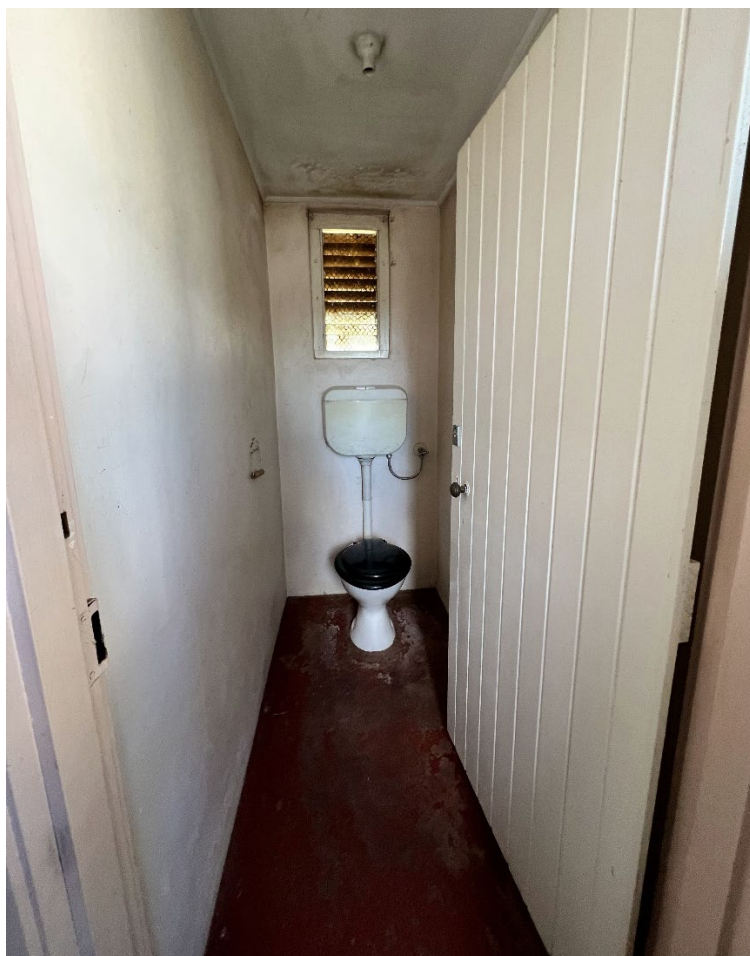
Figure 60 Plaster ceiling and walls are heavily soiled. Accumulation of dirt and grime to glass louvres. Light fitting is missing.
