Conservation Management Plan

P11375 MANJIMUP INFANT HEALTH CENTRE (FMR)

# BUILDING CONDITION ASSESSMENT

## Manjimup Infant Health Centre (fmr)

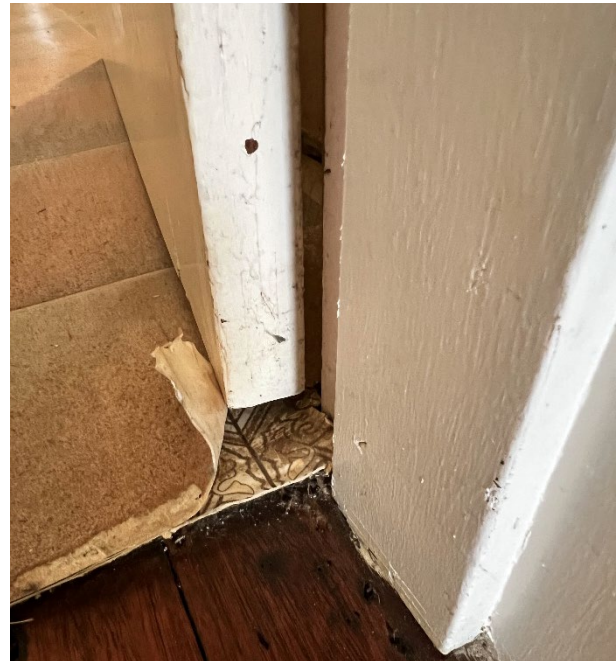
Figure 55 Vinyl layers to kitchen floor

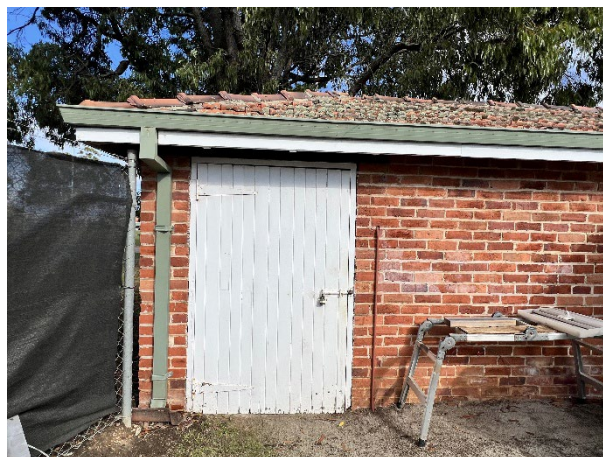
Figure 66 Garage

The garage is a single storey brick building with tiled roof at the rear of the site. The garage follows the same orientation as the main building. Two hinged timber panelled doors provide vehicular access from Rutherford Street. The east elevation features a wide timber panelled access door. The gutters and downpipes to the building have been replaced with a modern profile. A steel fence runs between the garage and the main building.

The garage at the rear of the site is in sound condition, however there is evidence of termite damage.

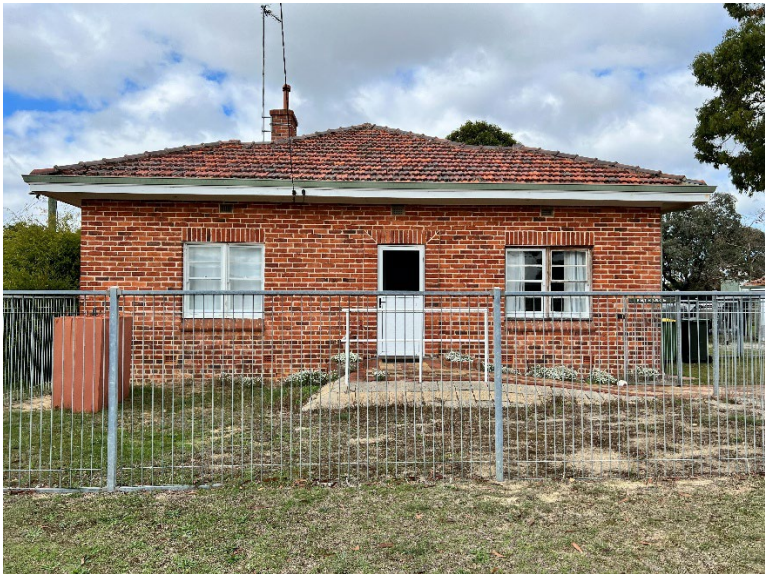
Figure 2 View of northwest elevation with modular panel fencing in the foreground.

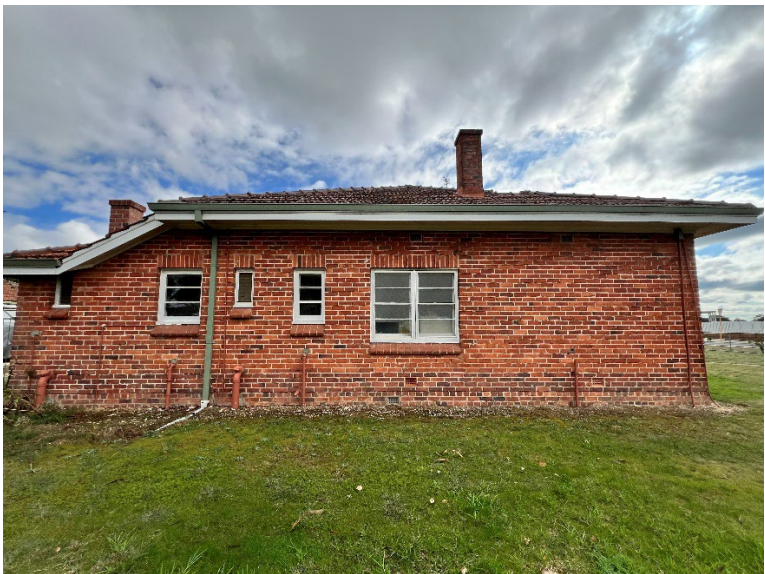
Figure 3 View of southeast elevation

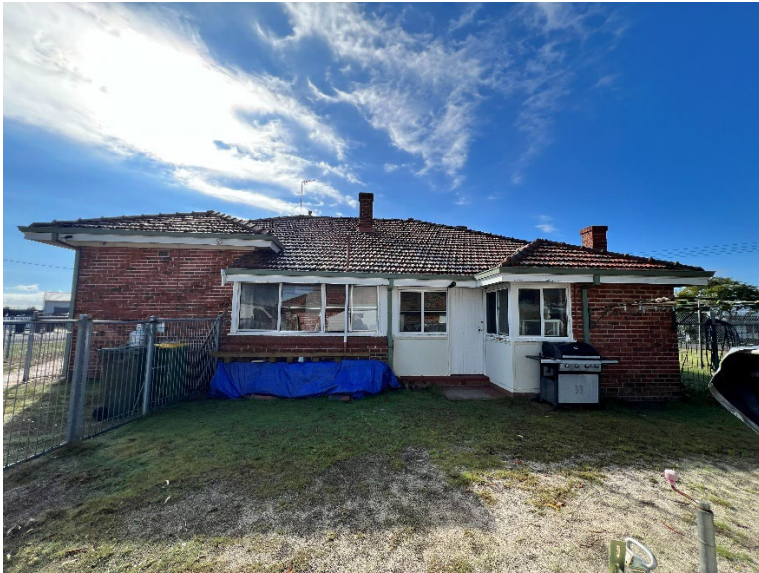
Figure 4 View of southwest elevation.

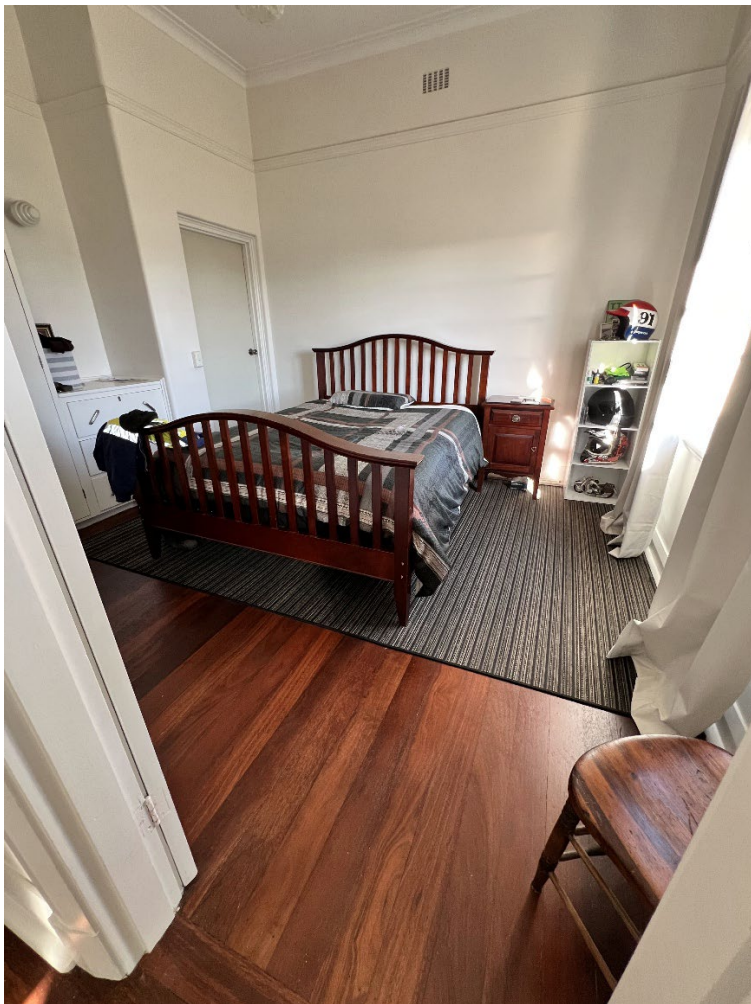
Figure 30 View of bedroom with door to sleepout on the west.

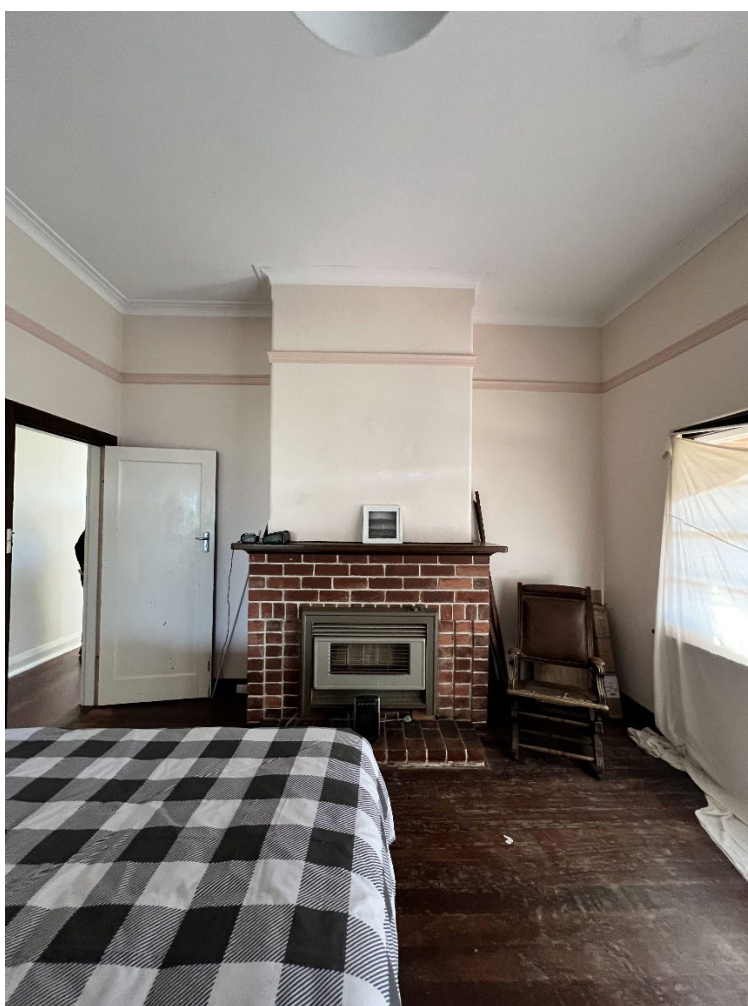
Figure 32 View of waiting room. Fireplace is fitted with kerosene heater.

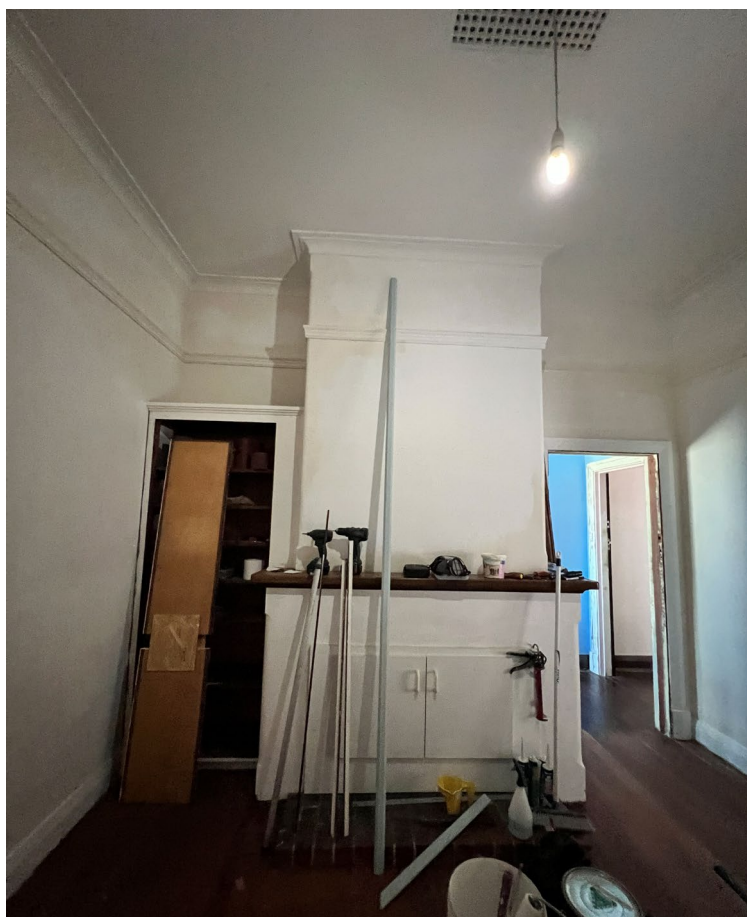
Figure 35 View of consulting room. Firebox fitted with cabinetry.

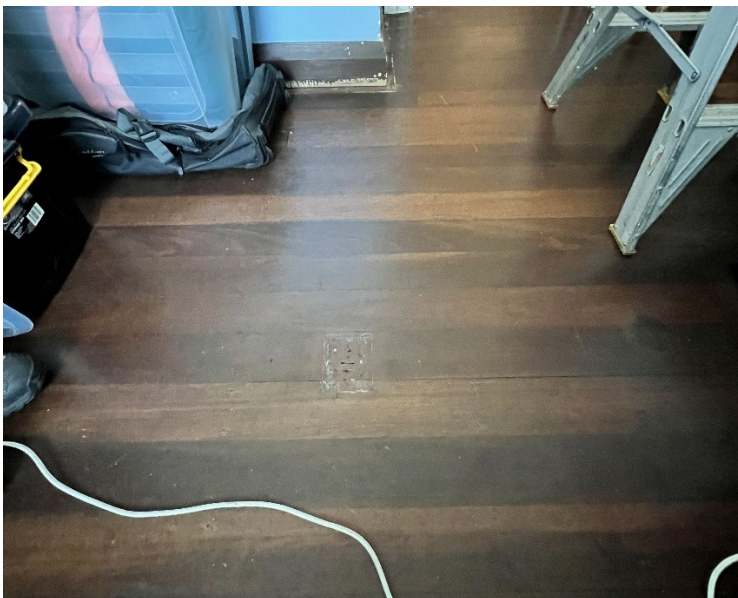
Figure 38 Evidence of central support post location on floorboard.

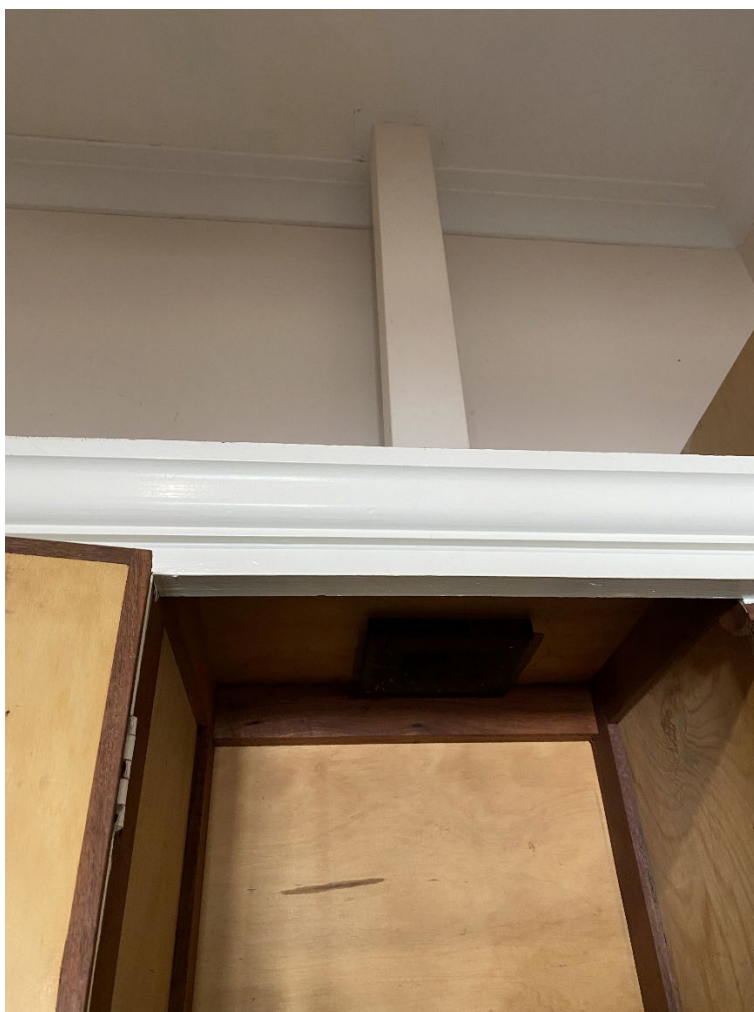
Figure 43 Original pantry cabinet with passive ventilation system (air exhaust).

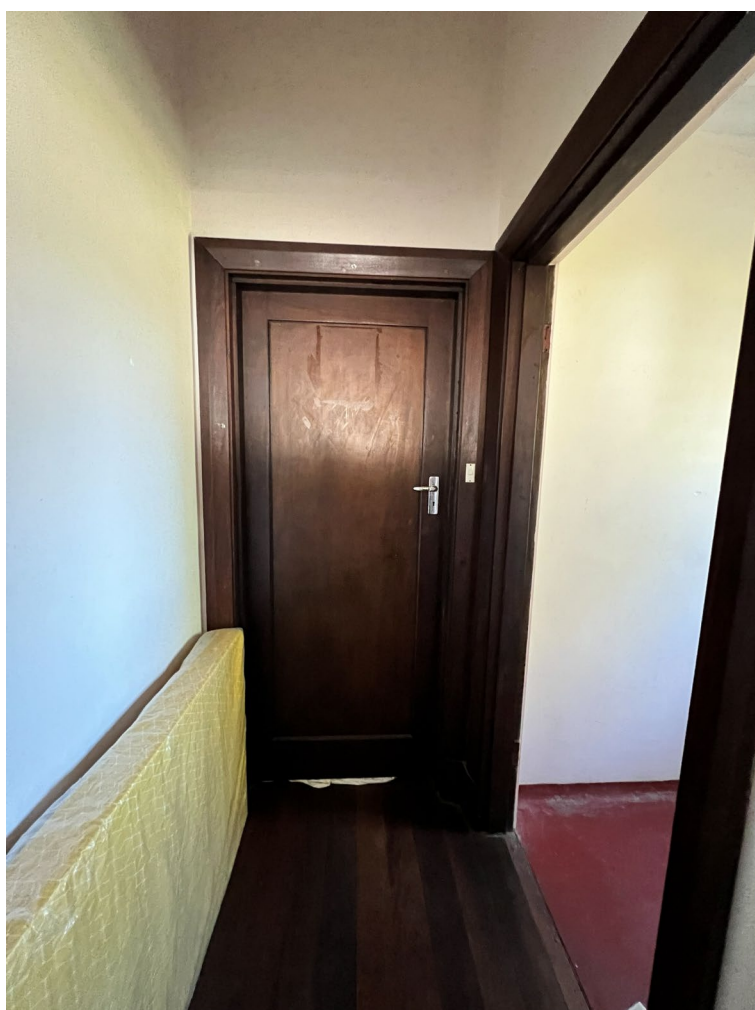
Figure 48 View of Hall 2 with washroom to the right.

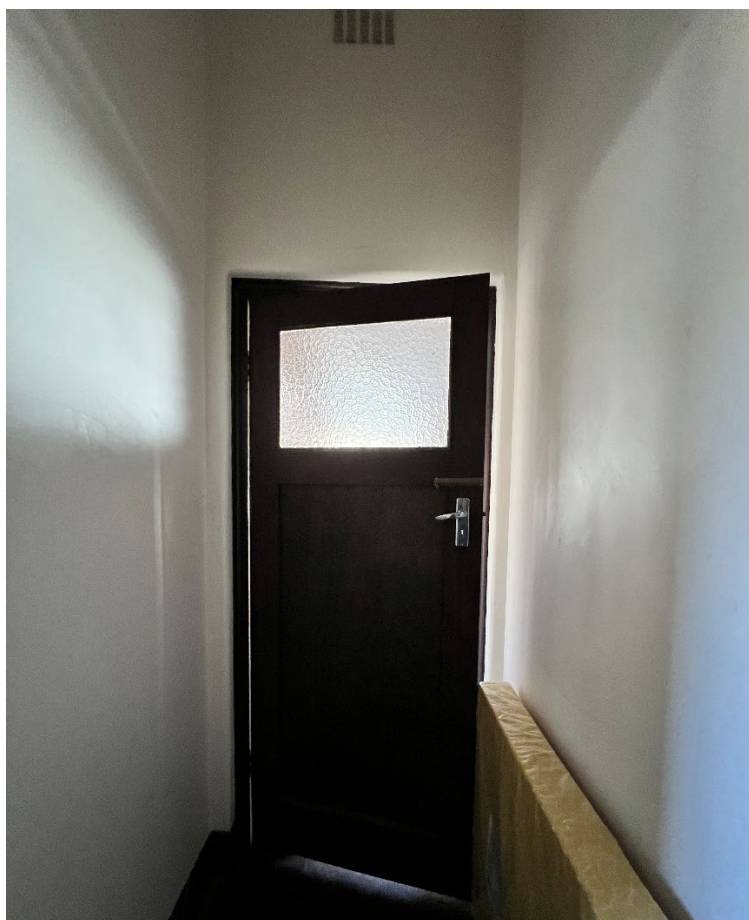
Figure 49 View of Hall 2 with door to verandah.

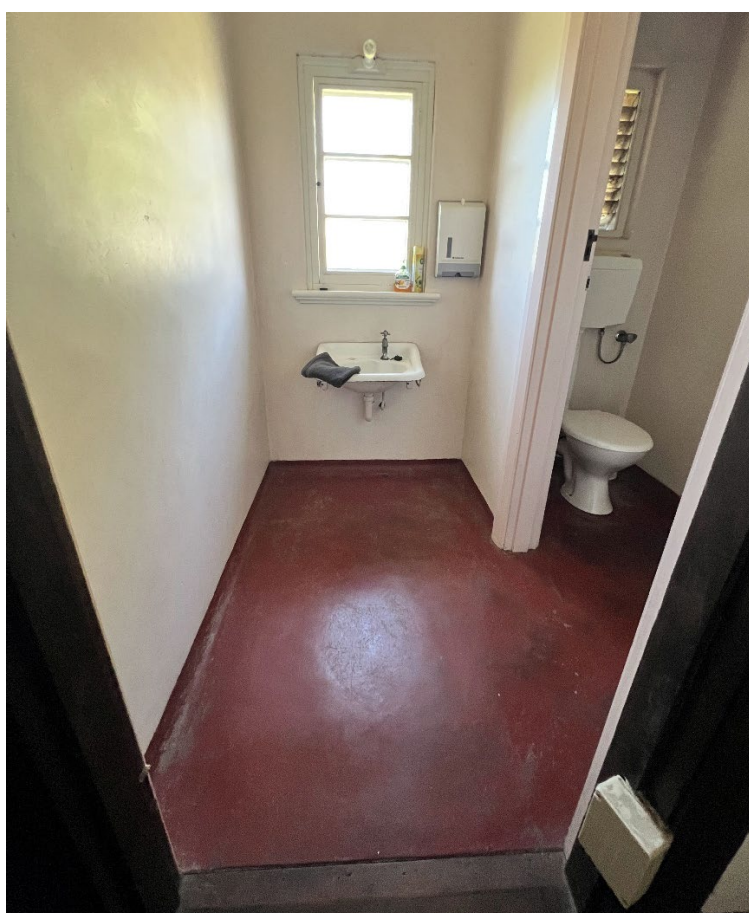
Figure 50 View of washroom with WC 1 to the right.

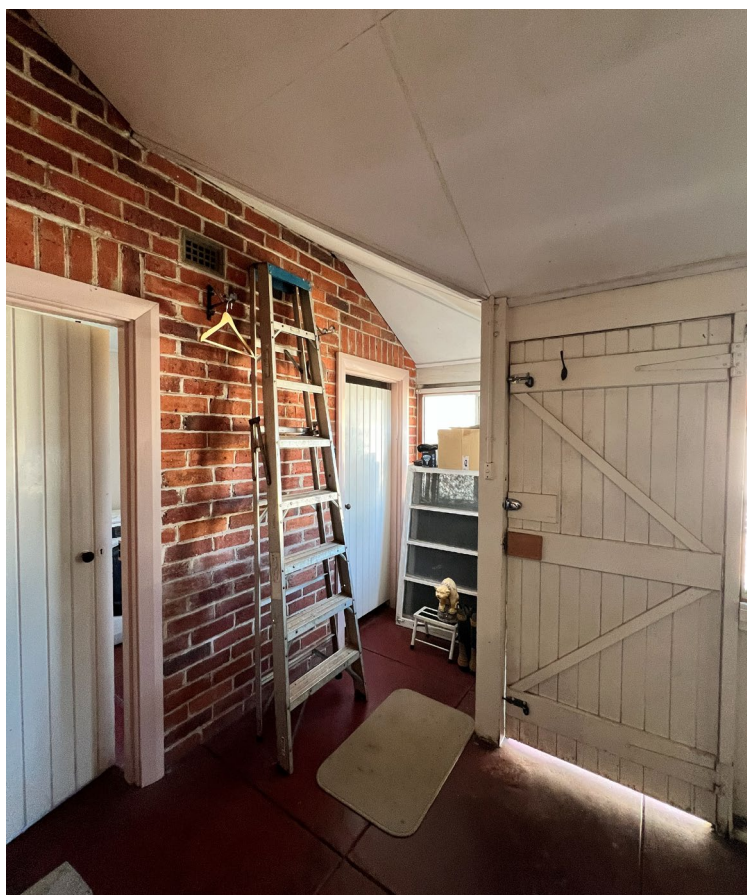
Figure 55 View of verandah with doors to laundry and WC2.

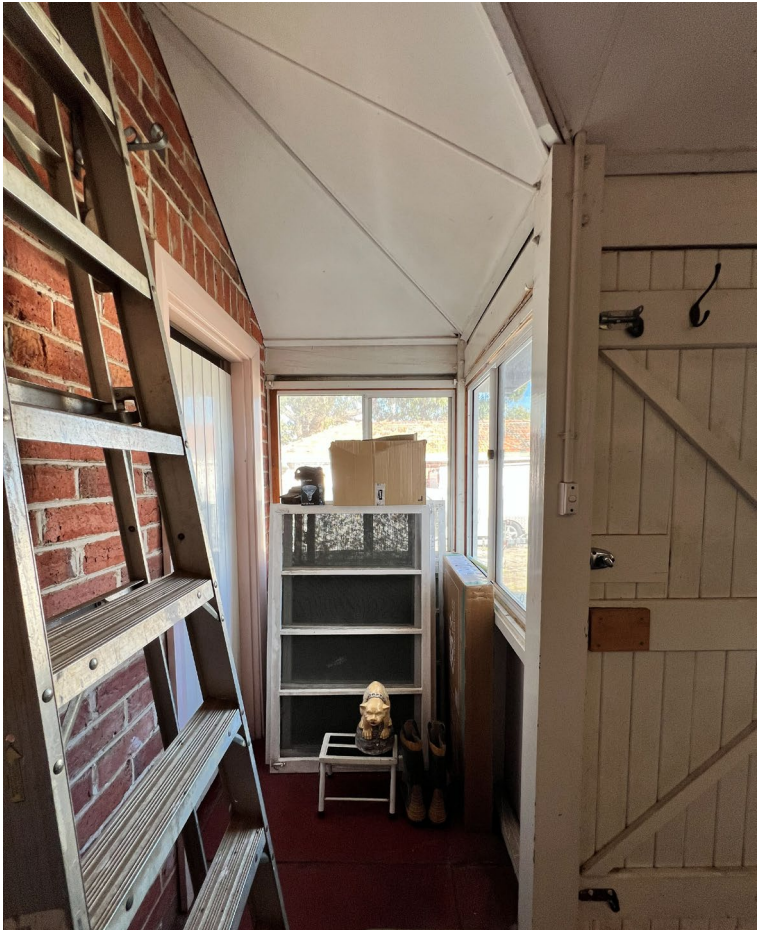
Figure 57    Aluminium framed windows to verandah enclosure.

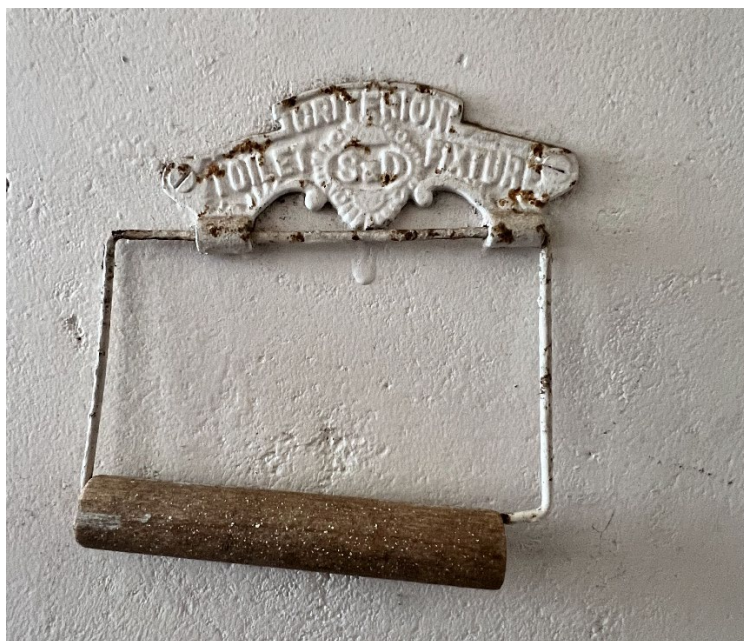
Figure 61 Original toilet roll holder is extant.
