WINDY HARBOUR DRINKING WATER SUPPLY

Quarterly Report

October 2025 – December 2025

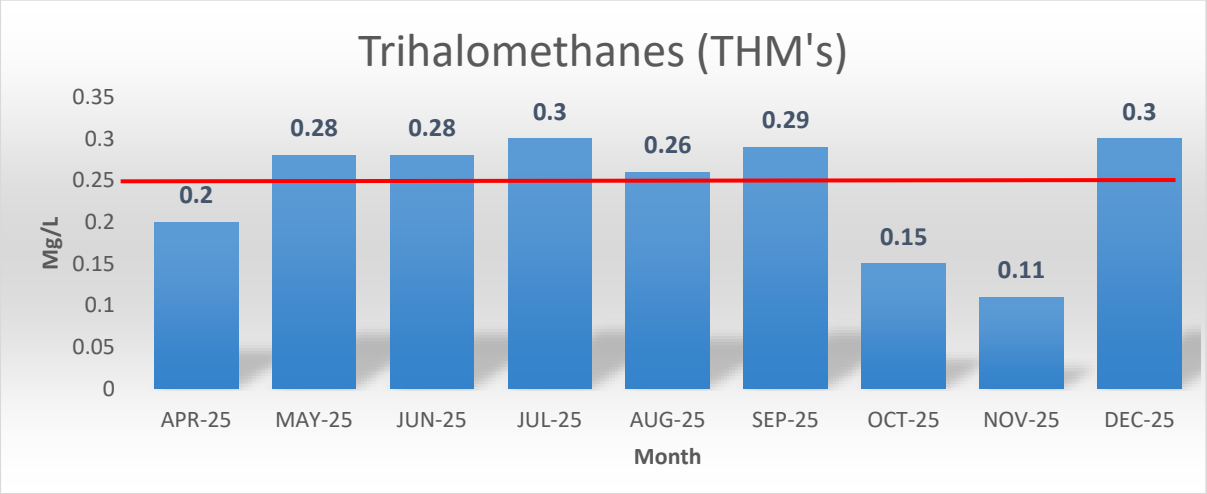
Figure 1: Trihalomethane (THM) values over the recent months (mg/L)

Trihalomethanes (THM's) exceeded the maximum recommended value in December 2025. However, the months of October and November 2025 were compliant with the recommended value.

THMs (Trihalomethanes) are organic disinfection by-products and indicative of the natural organic matter in the source water prior to disinfection. The Shire will continue to monitor individual and trending results via its monthly sampling program.

Date of Sample	Characteristic	Unit	Health Related Recommended Value (Max)	Sample Result
3/12/2025	Trihalomethanes	Mg/L	0.25	0.30

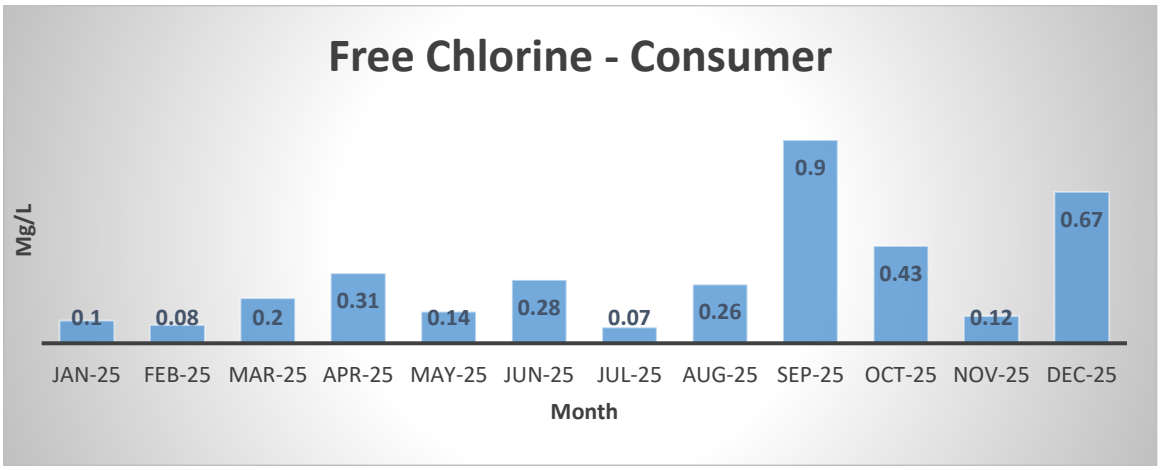
Figure 2: Free Chlorine values over the recent months at the consumer sampling point (mg/L)

Free Chlorine values were satisfactory for the period despite the sampling period being the high season period. Notwithstanding, the microbiological quality of the water was not compromised and will continue to be maintained in the future.
