WINDY HARBOUR DRINKING WATER SUPPLY

Quarterly Report

January 2026 – March 2026

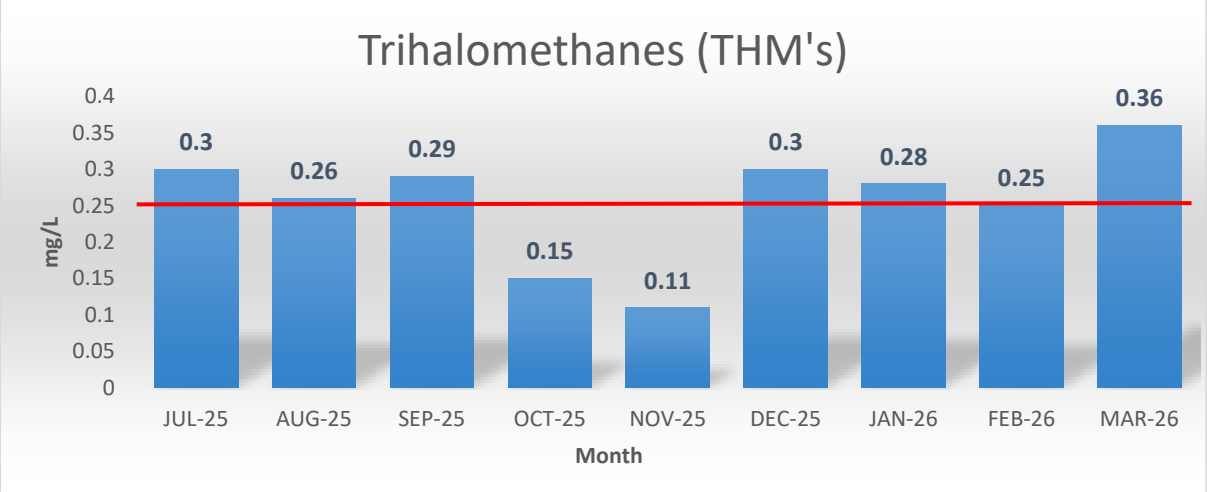
Figure 1: Trihalomethane (THM) values over the recent months (mg/L)

Trihalomethanes (THM's) exceeded the maximum recommended value in January and March 2026. However, the result from February 2026 was compliant with the recommended value.

THMs (Trihalomethanes) are organic disinfection by-products and indicative of the natural organic matter in the source water prior to disinfection. The Shire has engaged a contractor to clean the storage tanks in April 2026 and will continue to monitor individual and trending results via its monthly sampling program.

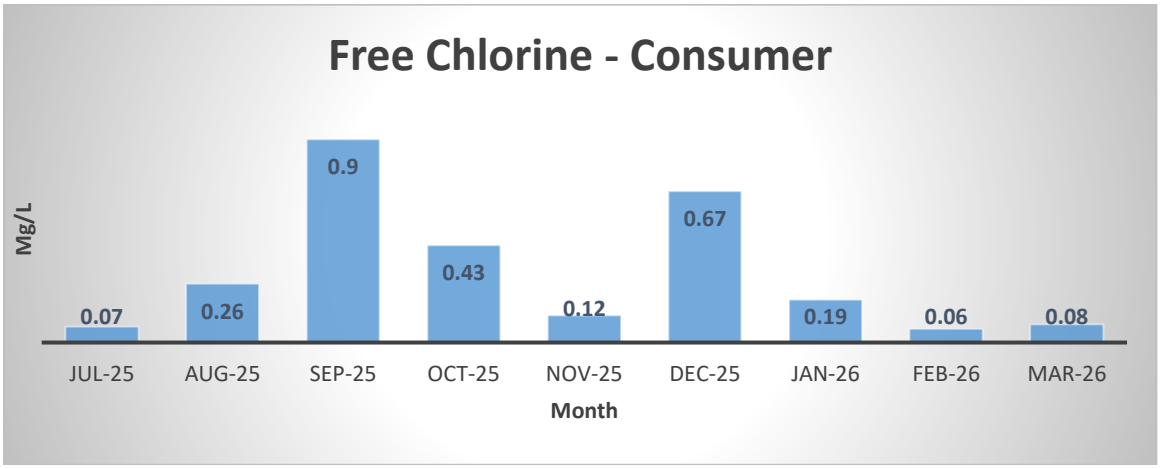
Figure 2: Free Chlorine values over the recent months at the consumer sampling point (mg/L)

Free Chlorine values were satisfactory for the period despite the sampling period being the high season period. Notwithstanding, the microbiological quality of the water was not compromised and will continue to be maintained in the future.
