Conservation Management Plan

P11375 MANJIMUP INFANT HEALTH CENTRE (FMR)

# BUILDING CONDITION ASSESSMENT

## Manjimup Infant Health Centre (fmr)

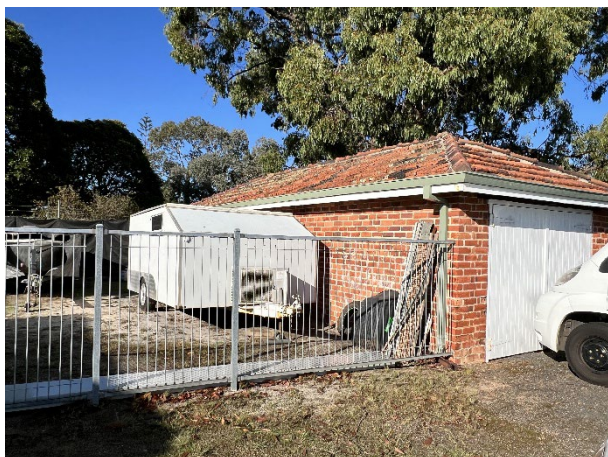
Figure 66 Garage

The garage is a single storey brick building with tiled roof at the rear of the site. The garage follows the same orientation as the main building. Two hinged timber panelled doors provide vehicular access from Rutherford Street. The east elevation features a wide timber panelled access door. The gutters and downpipes to the building have been replaced with a modern profile. A steel fence runs between the garage and the main building.

The garage at the rear of the site is in sound condition, however there is evidence of termite damage.

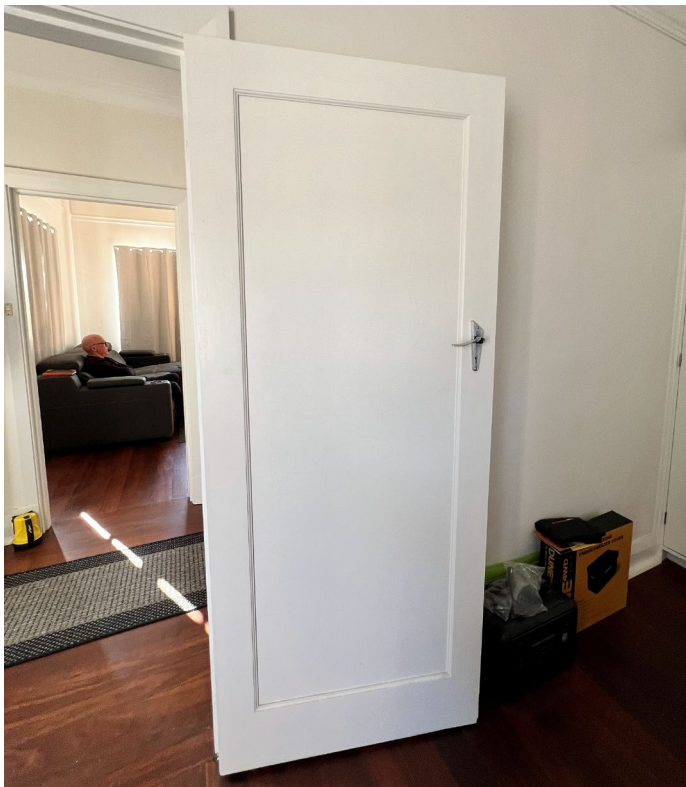
Figure 19 Internal door with central recessed panel in pine and jarrah surrounds.

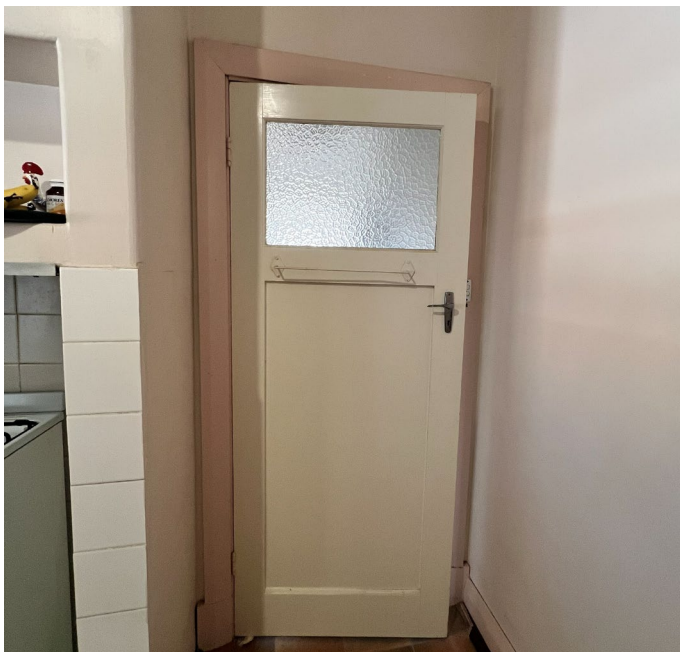
Figure 20 Kitchen door with top glazed panel with timber architrave.

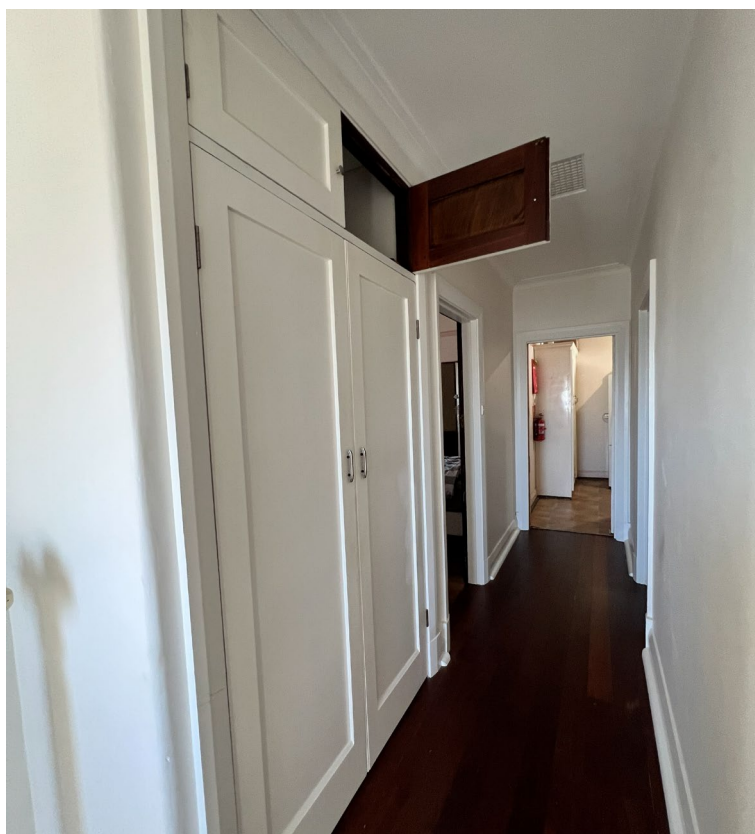
Figure 27 View of Hall 1. Original timber cabinetry to the left hand side.

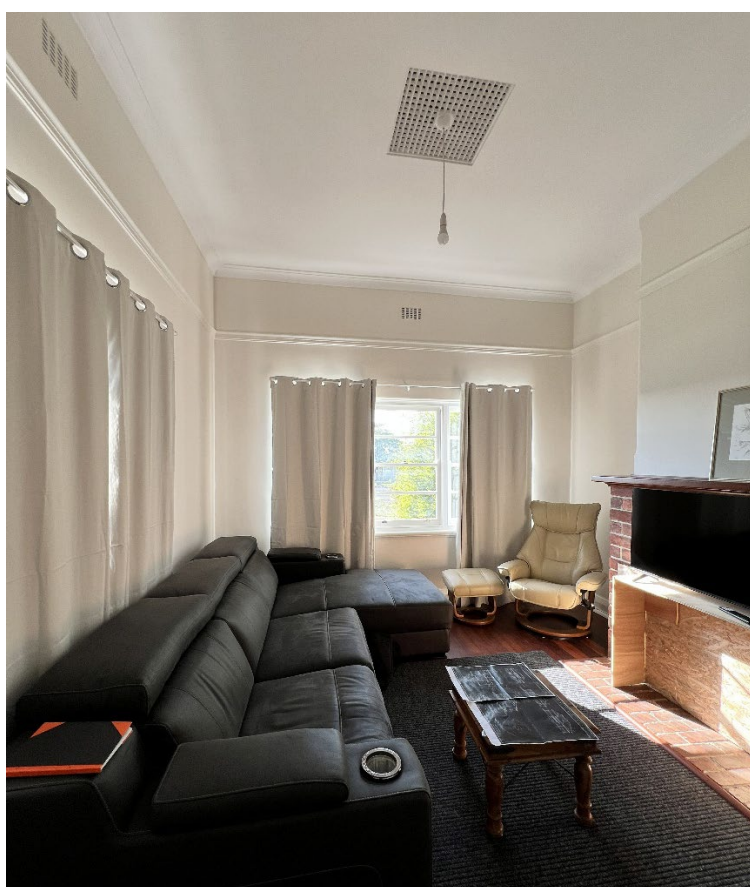
Figure 28 View of living room with the fireplace on the right.

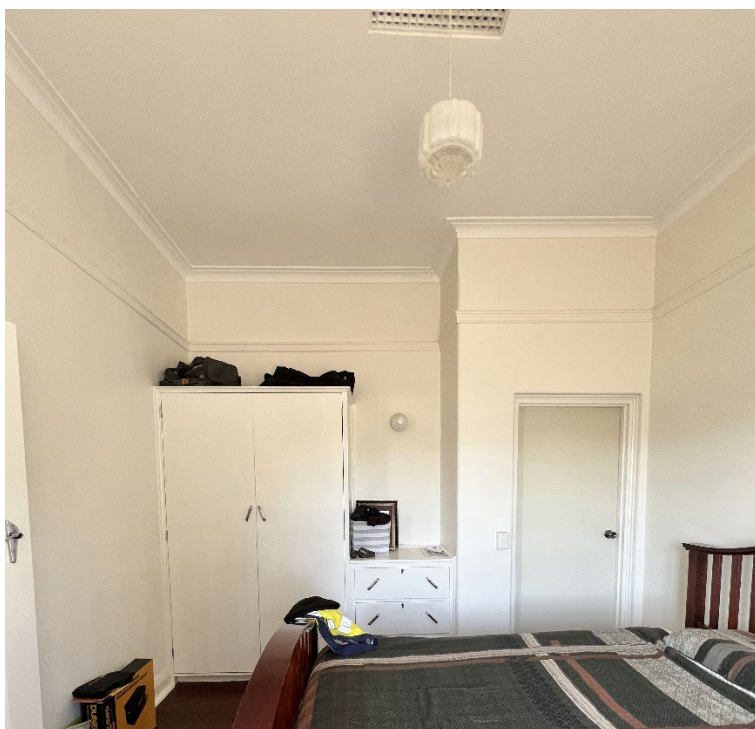
Figure 31 View of original closet and dresser with original pendant and wall light fittings intact.

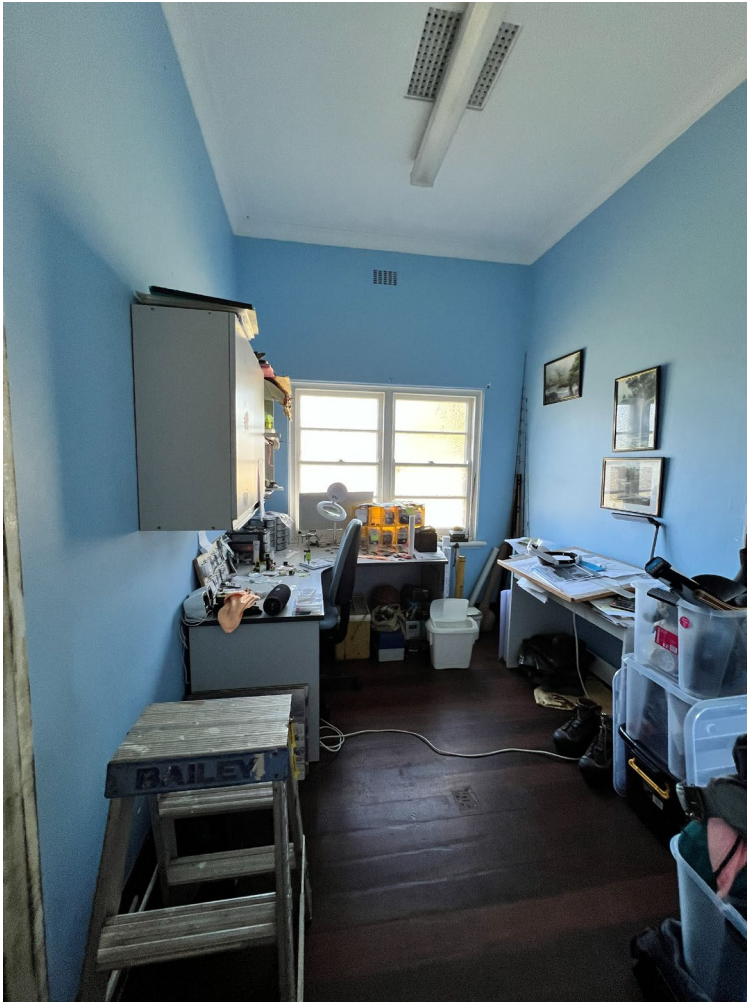
Figure 37 View of breastfeeding room.

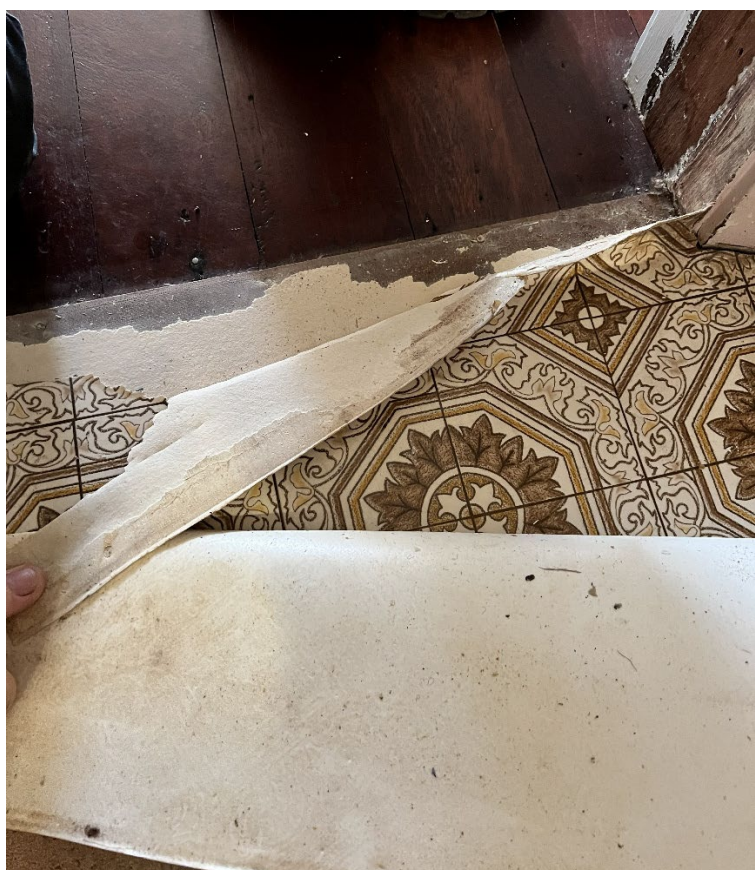
Figure 42 Layers of floor covering to kitchen floor.
